Canning Stock Route Audit Report

Prepared for Track Care WA
Author: Rod Durston
August 2022

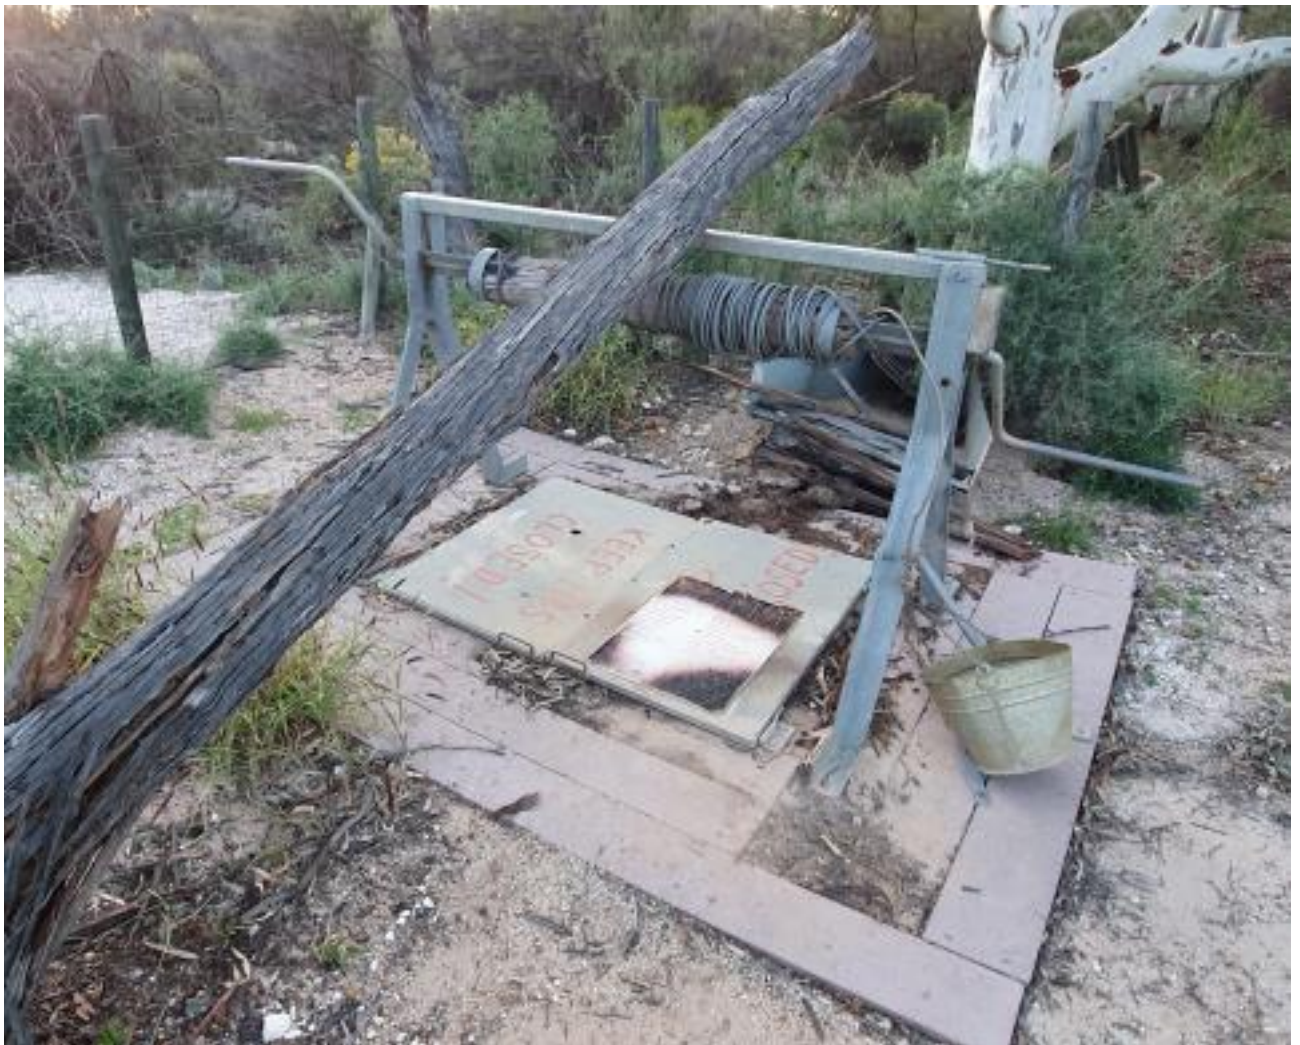
Well 3 Wakunpu

Restored Well, loose straps on copper log fence, termite eaten pole. Dense woodland around camp area, no shade, sand base.

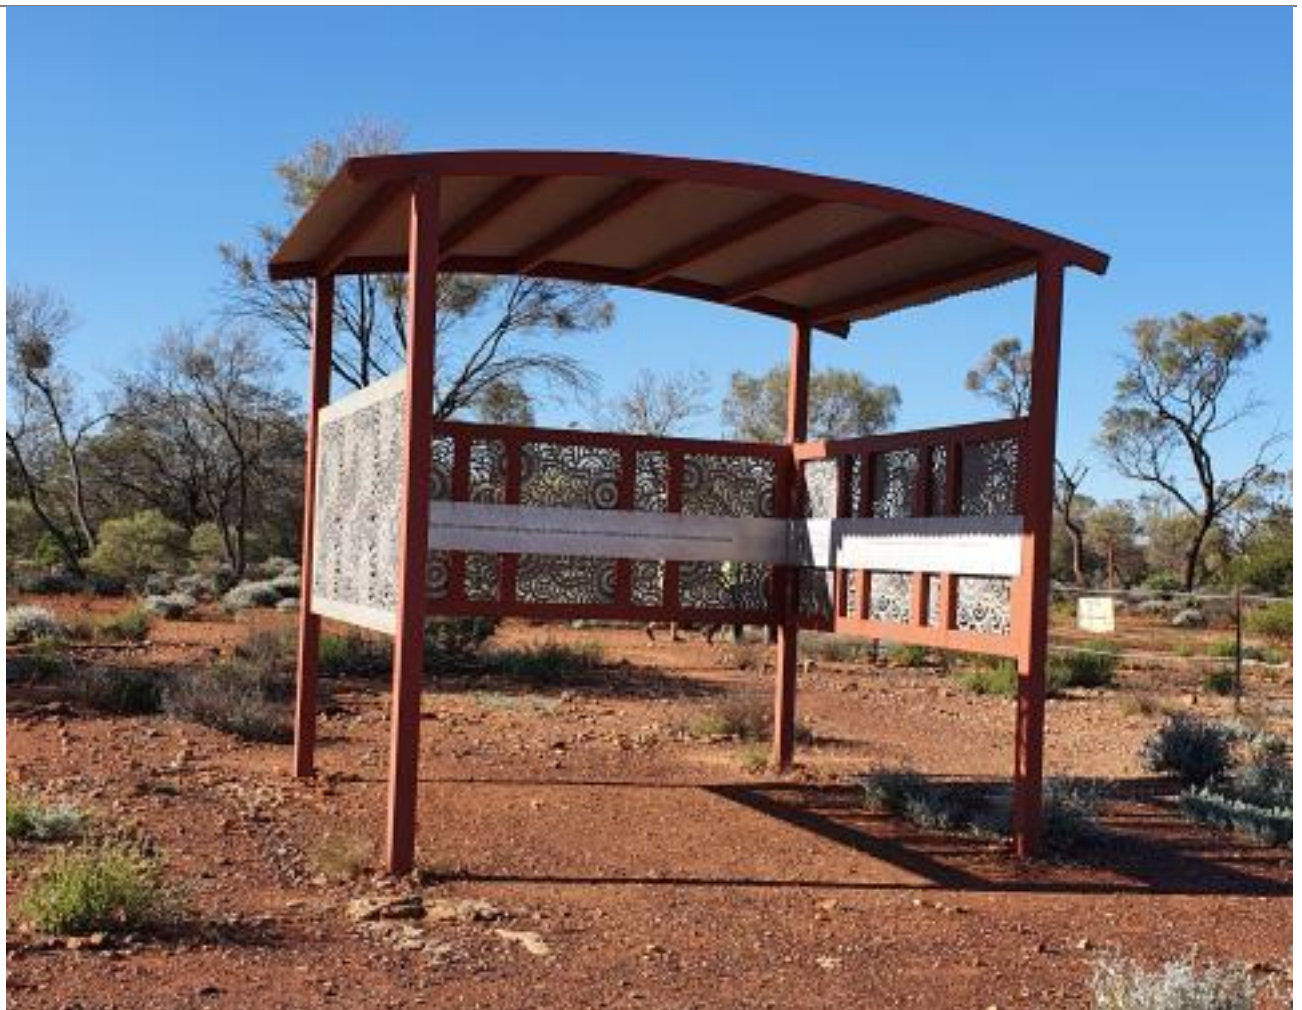
Windich Springs

Popular camping spot with abundant birdlife and permanent water supply. Shaded Information display, toilet in good repair, Solar light needs replacing, picnic tables x2, gravel/stone base, dense woodland along creek.

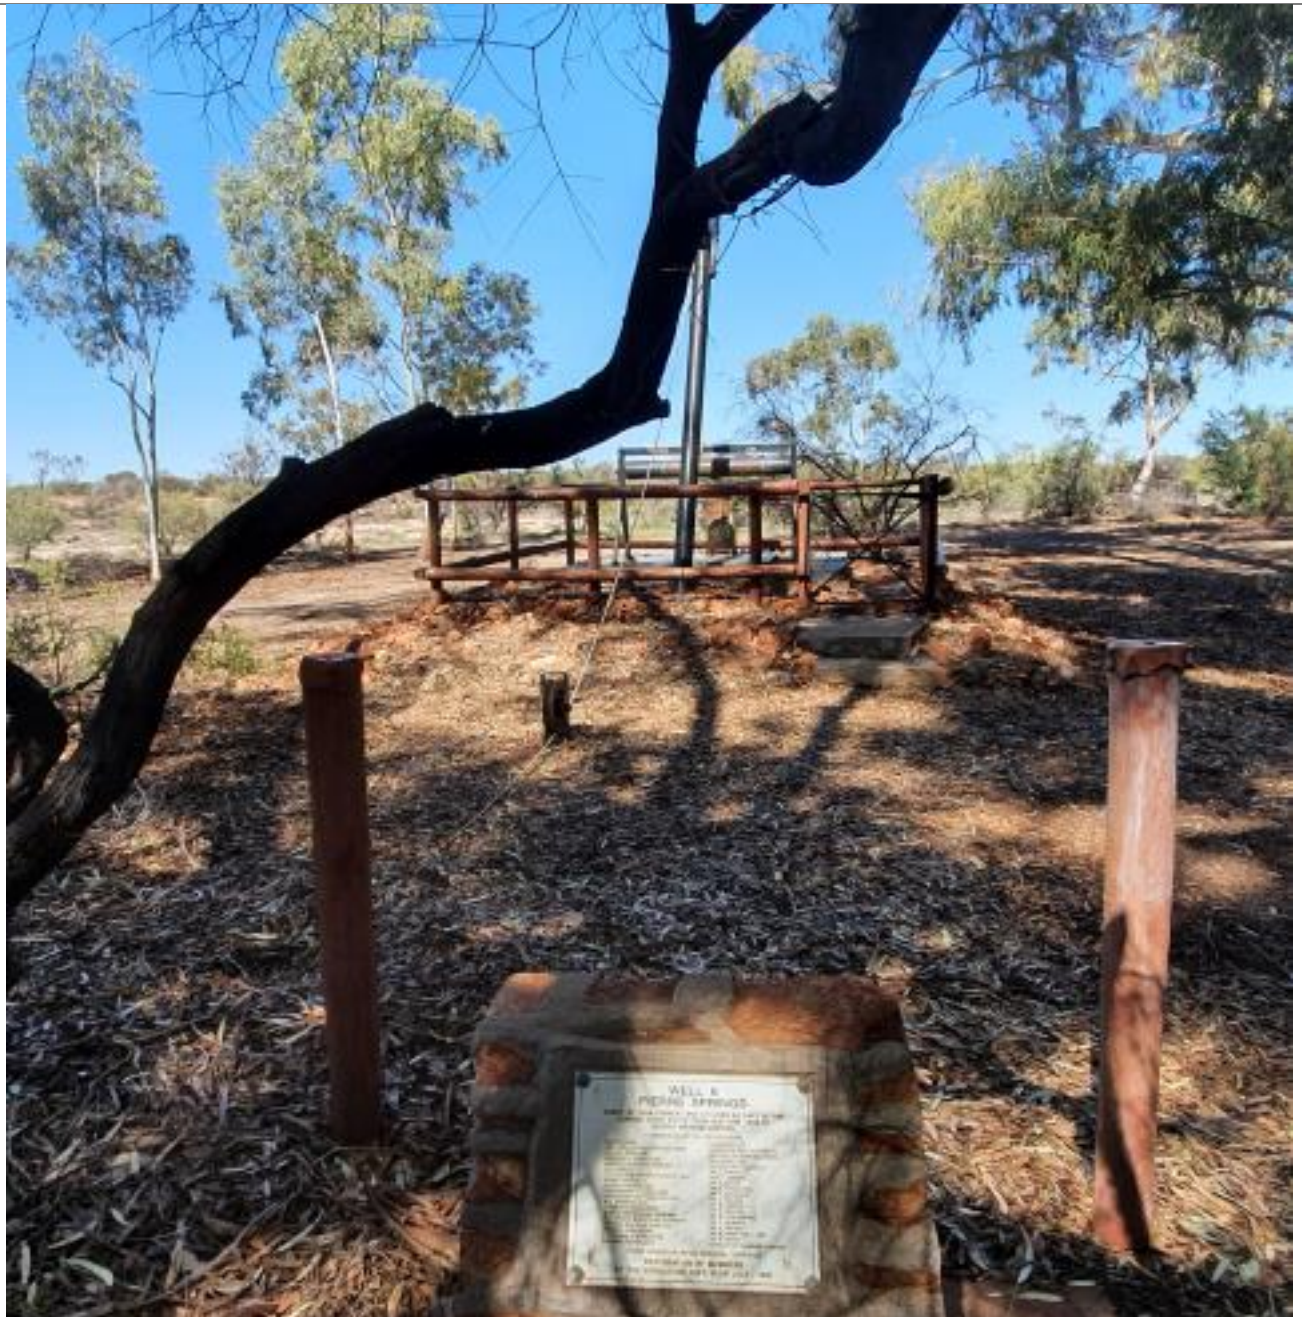
Well 6, Milyinyiri, Pierre Spring

Restored, in good repair, toilet in good repair, skirt 900x630x400 needs replacing, BBQ x1 very rusted at base, x2 additional fire pits, heavy shade from large white gums, leafy/ground base, Caltrop weed on track to dunny and surrounding scrub.

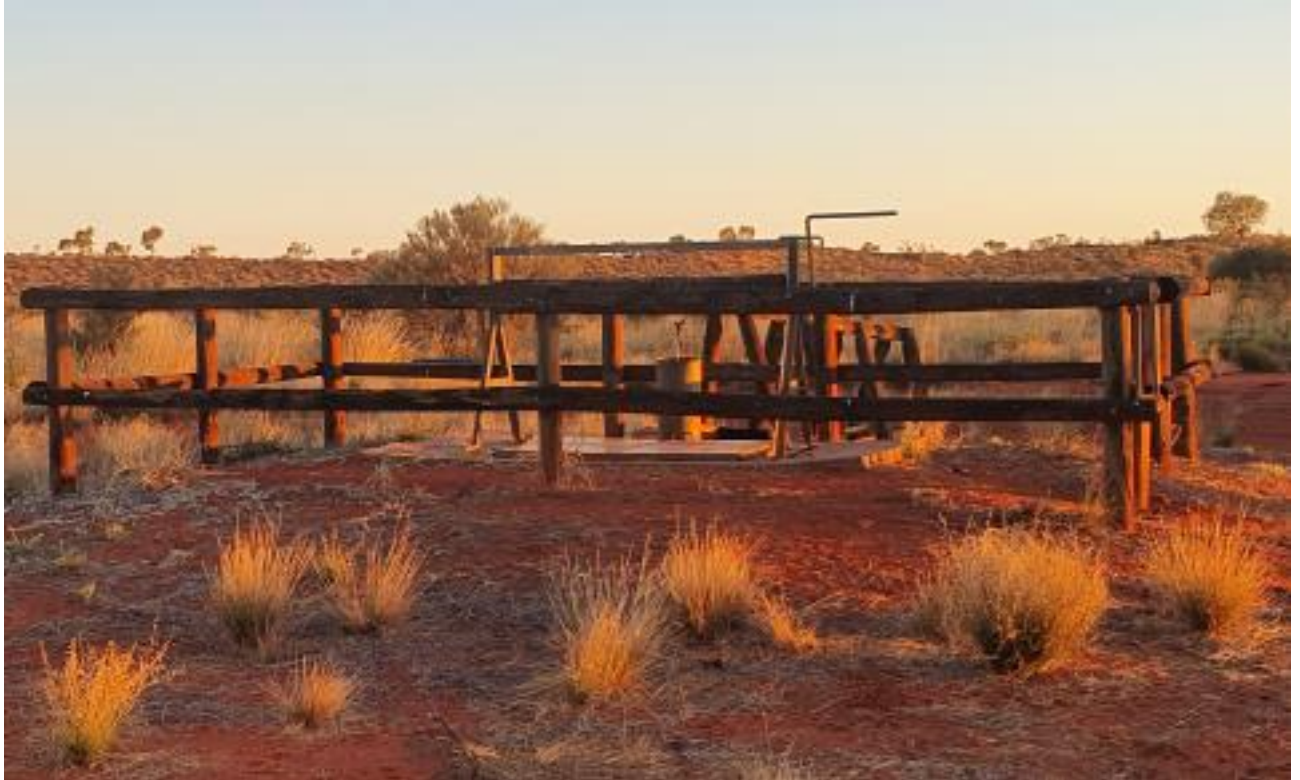
Well 12

Restored, in good repair. Toilet in good condition, toilet signs ok, drums used as signage, need new solar light, good camp site, Desert Oaks, ground sand based

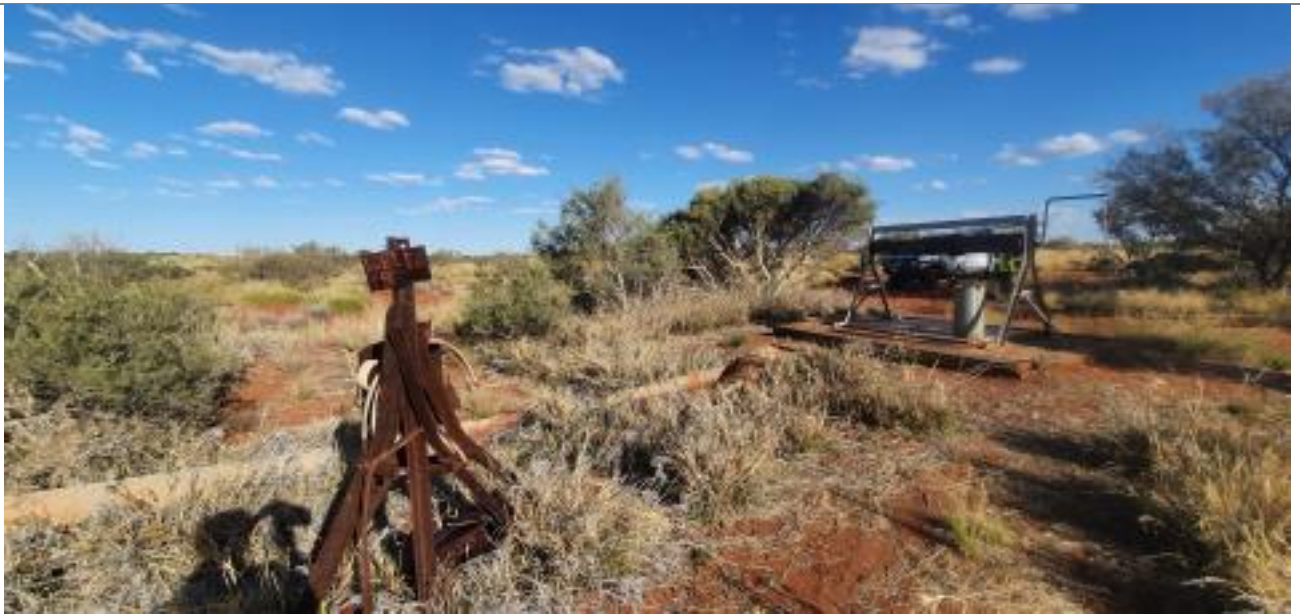
Well 18, Wanykuju

Restored, in good repair, top well boards badly damaged from termites, scrub, little shade, only small area to camp.

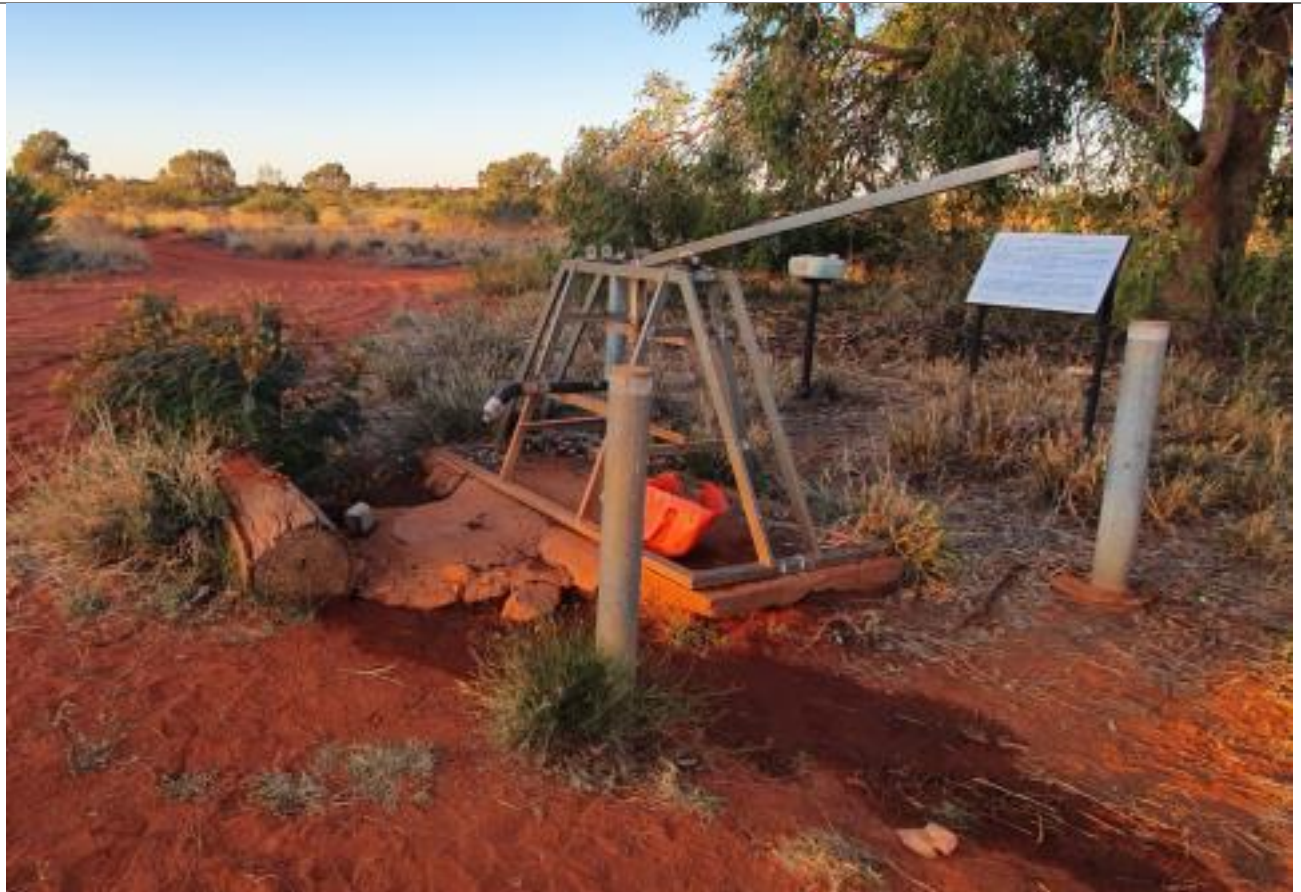
Georgia Bore

Site has many camping spots, a good bore water supply and toilet. Enviro toilet tank in place next to current toilet but use unknown. 1x BBQ destroyed, 2x BBQ in good repair,

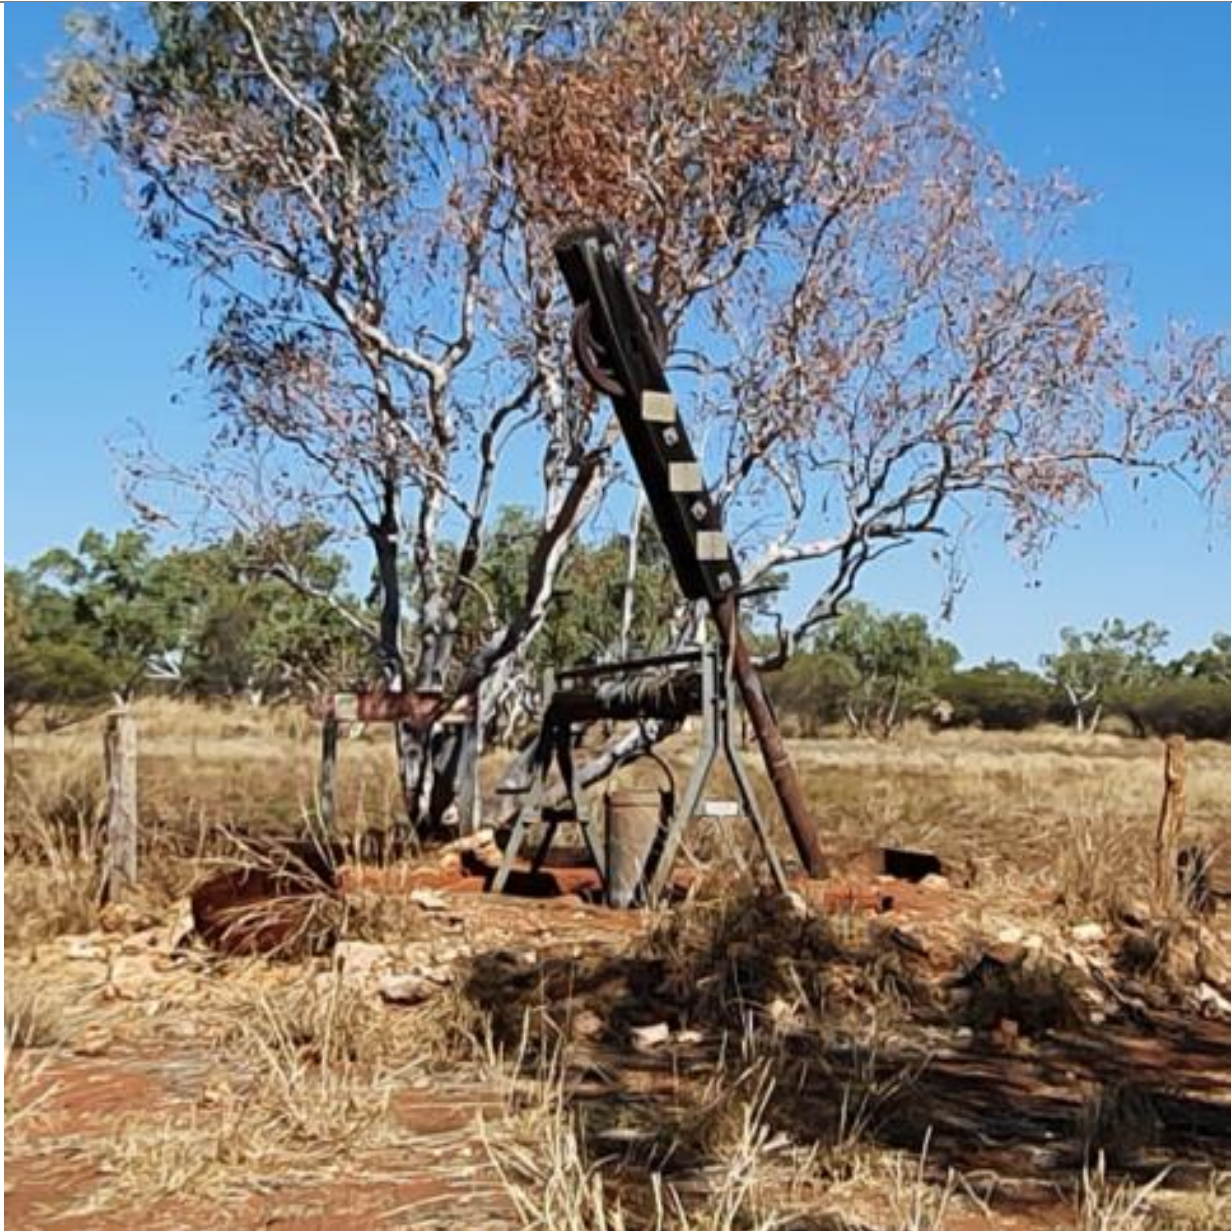
Well 46, Kuduarra**Lat. -20.641777 Long.126.287671**

Well in poor state of repair due to fire. Windlass & bucket in good condition, (steel) whip pole in good condition. Temporary repair of a Ute tray used to cover open well, windlass secured to top of tray. Burnt rubbish strewn around, bottles & cans in burnt heap, signage burnt. x2 fire pits (cut barrel) submerged in soil. Toilet in good state of repair, waste sign in good condition, solar light working. Large area to camp, ground base, few trees, low scrub, little or no shade.

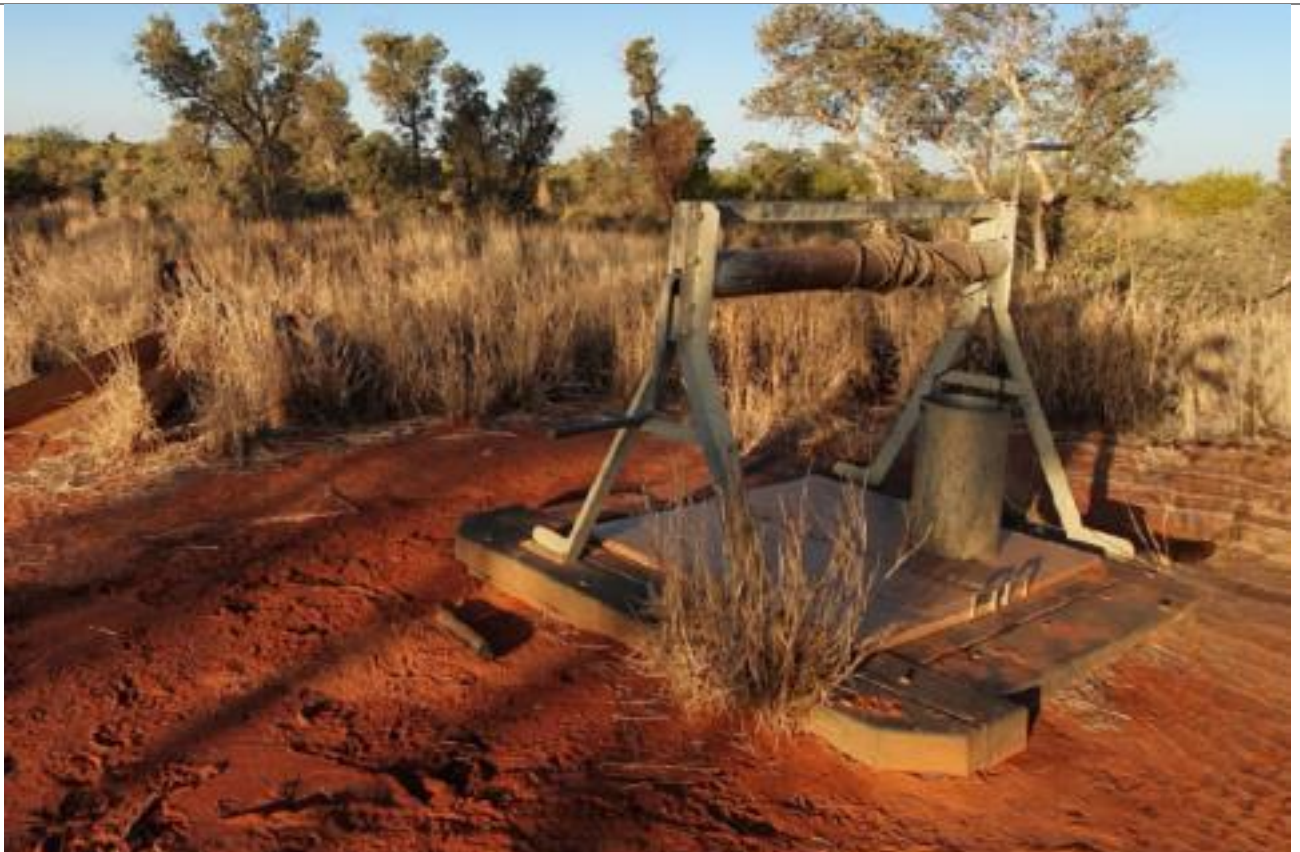
Well 49, Lampa

Well in good repair. Ranger's station, double toilet in good repair, no solar light, trailer tyre to be renewed. Waste dump point heavily overgrown, alternate dump site to be found. Small camp area, sand base, low trees/scrub, Buffel grass.

Some of the toilet trailer tyres at Derba Springs and Well 49 needs replacing and the toilet at Lake Stretch is in a dangerous state due to termite damage. At the time of writing it's unknown who

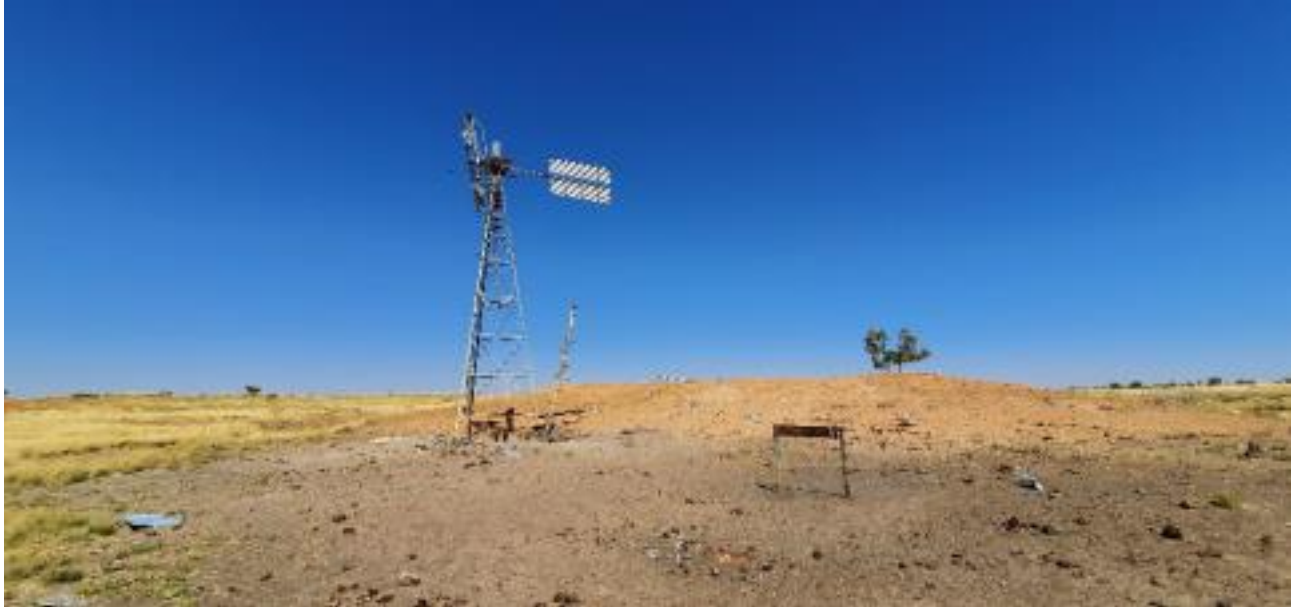
Well 51, Wirrijarra**Lat. -20.147733****Long. 127.146307**

Unmaintained, filled in and windmill severely damaged. Open & exposed.

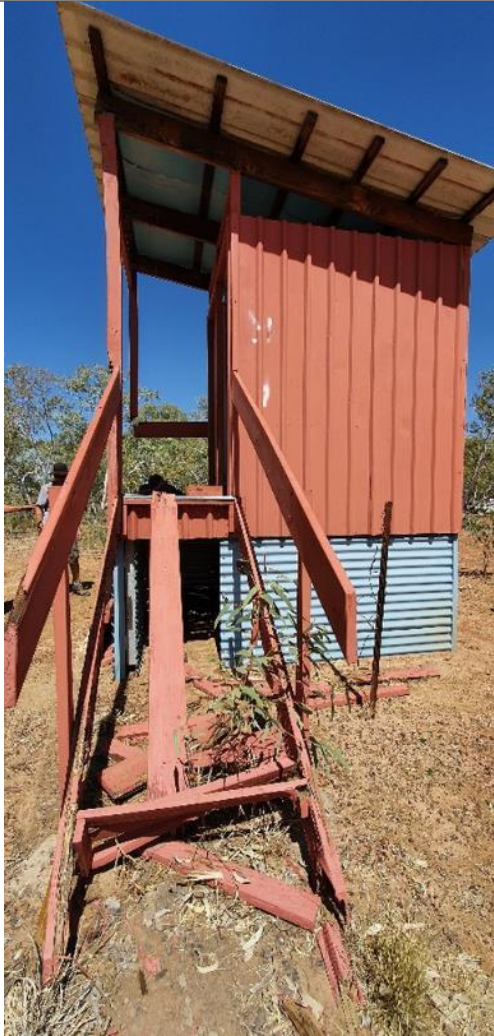
Structure has significant termite damage and is in a dangerous condition. Composting bin and pedestals seem to be ok. Solar system present but unknown use or condition.

constructed this toilet and therefore who should repair it. It will be a major project to complete as it requires a complete rebuild. Apart from some minor repairs undertaken, in general the toilets are in good condition there does not seem a need for extra toilets along the CSR.
