Canning Stock Route Audit Report

Prepared for Track Care WA
Author: Rod Durston
August 2022

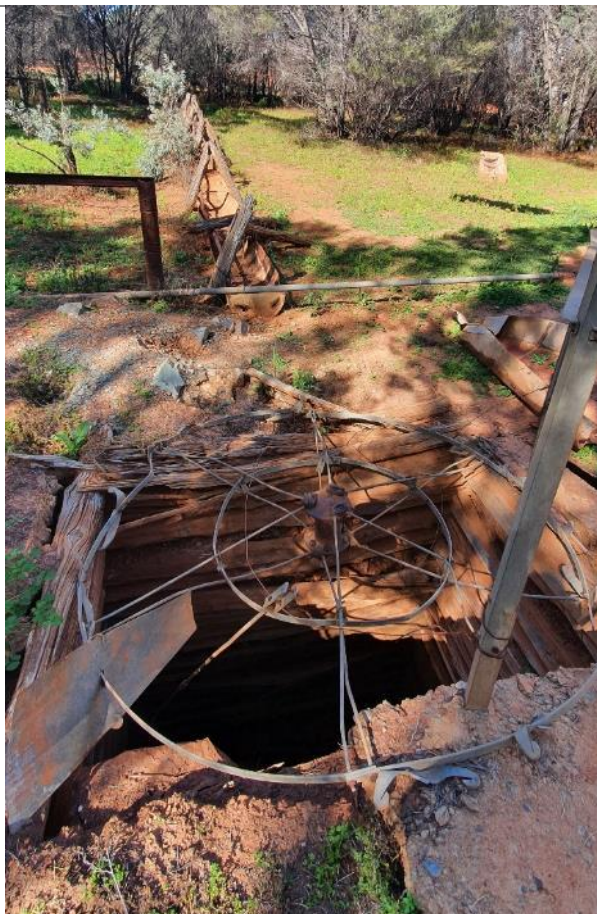
Well 1	Lat. -26.558031	Long. 120.181659
Description		
Still contains some water but unmaintained. Water tanks, dense woodland around well area, gravel/mud base, boggy when wet.		
Drinking Water <input type="checkbox"/>	Toilet <input type="checkbox"/>	Campsite <input type="checkbox"/>
River/Creek <input type="checkbox"/>	Grass <input type="checkbox"/>	Donation Box <input type="checkbox"/>
Vegetation	Low <input type="checkbox"/>	Med <input checked="" type="checkbox"/>
		High <input checked="" type="checkbox"/>
		Shade <input checked="" type="checkbox"/>
		BBQ <input type="checkbox"/>
		Signage <input checked="" type="checkbox"/>
		Animal Use <input type="checkbox"/>

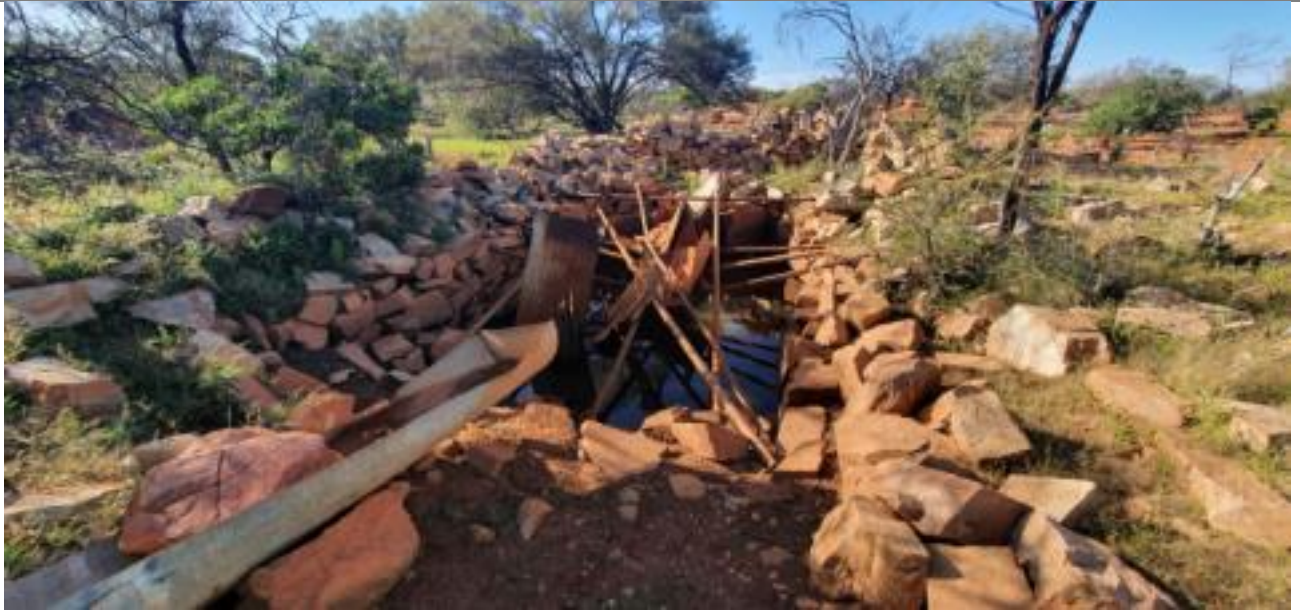
Well 2A The Granites

Some water but mostly destroyed. Low scrub

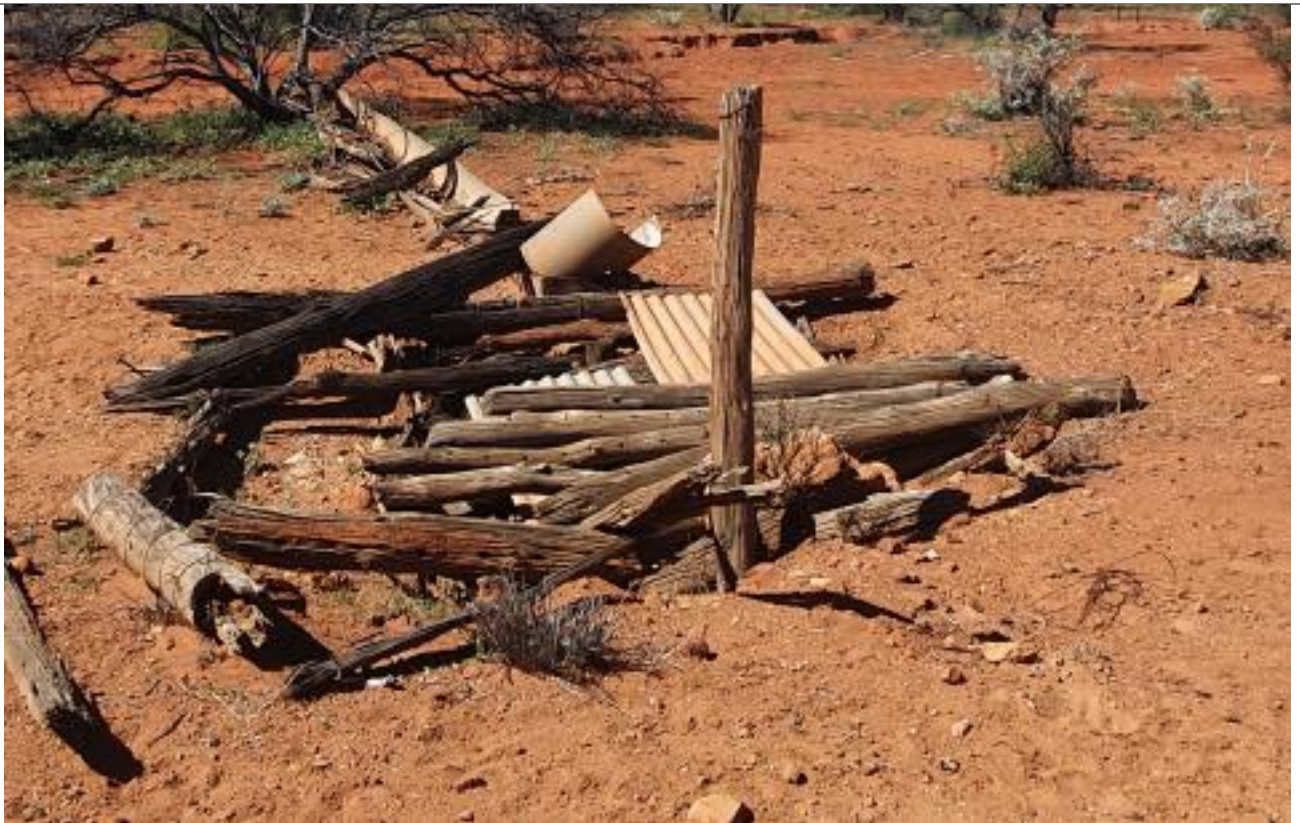
Scattered timbers and iron covering well but largely destroyed. Degraded woodland surrounds, sand base.

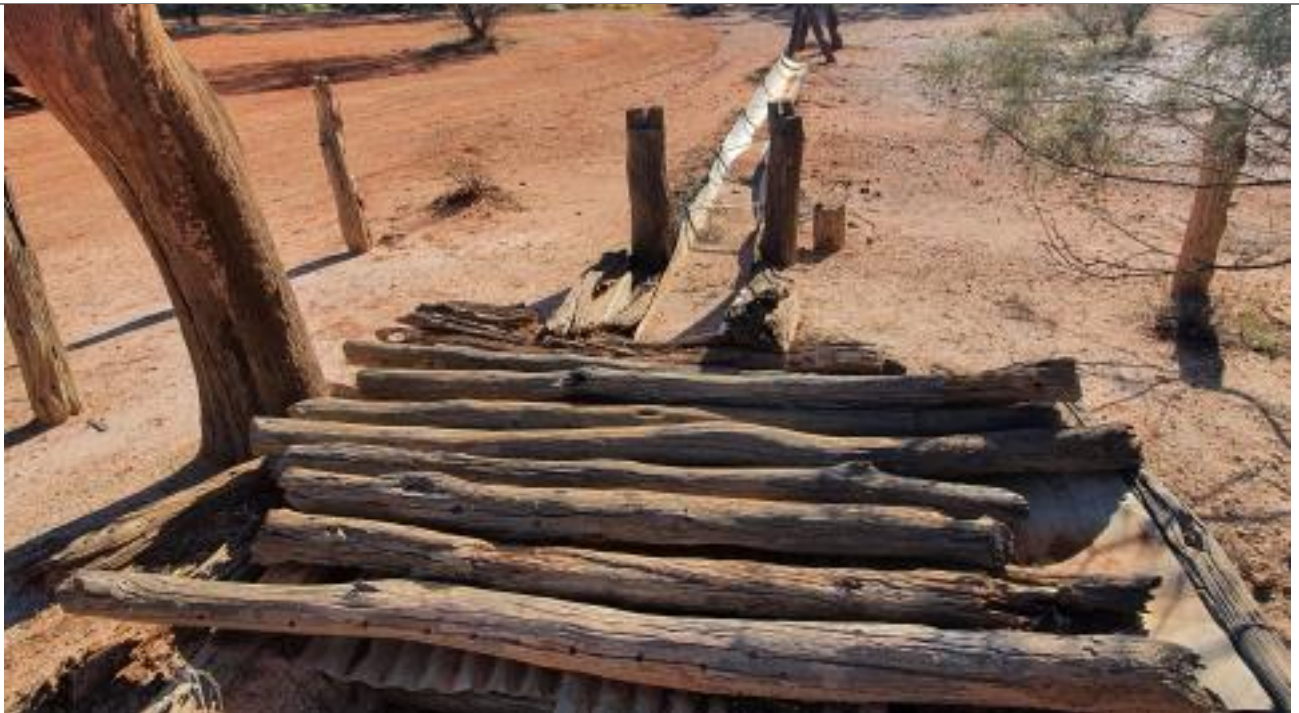
Well 4A

Unmaintained covered with iron and timbers, gravel base, White Gums along creek, Caltrop weed present, Survey marker nearby

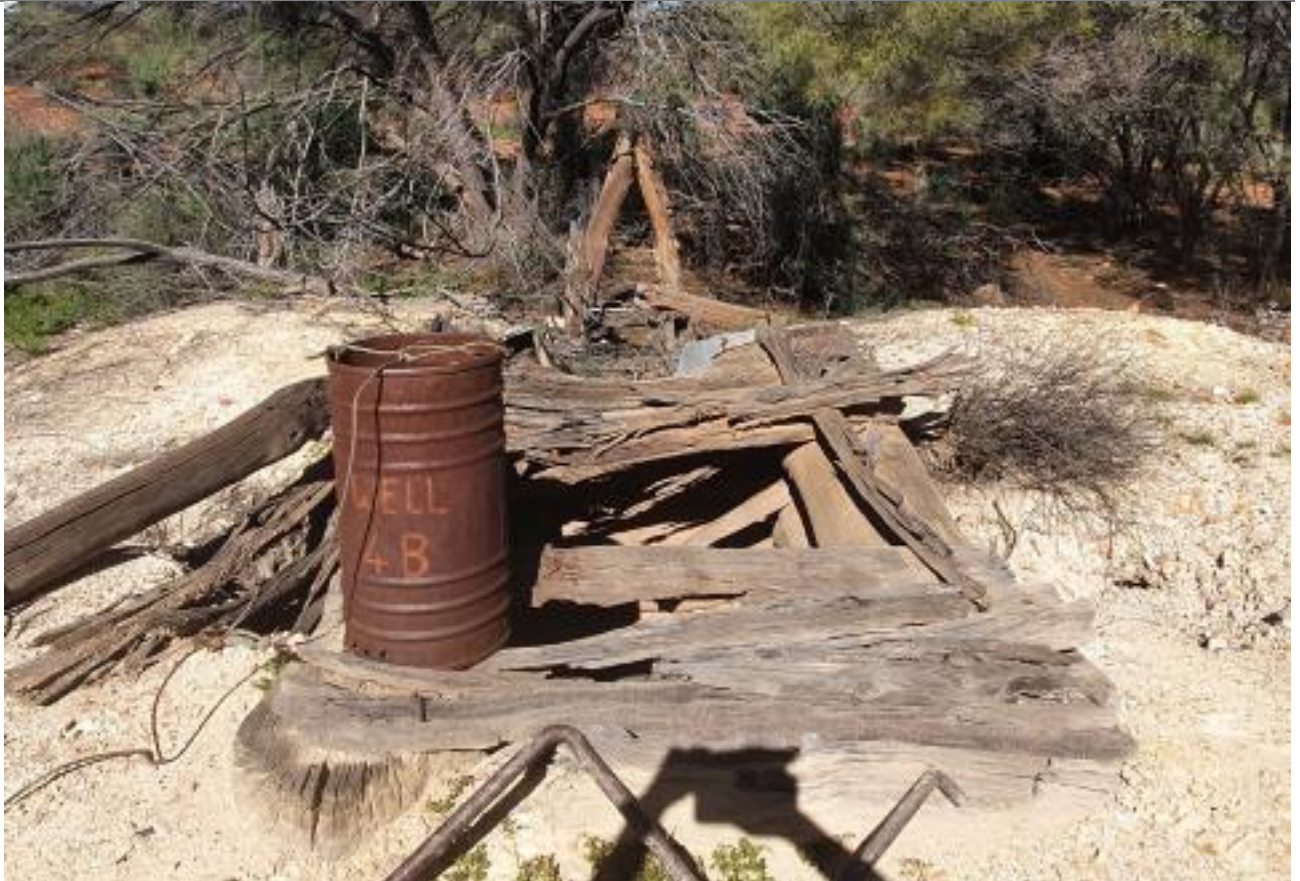
Unmaintained with timbers covering well.

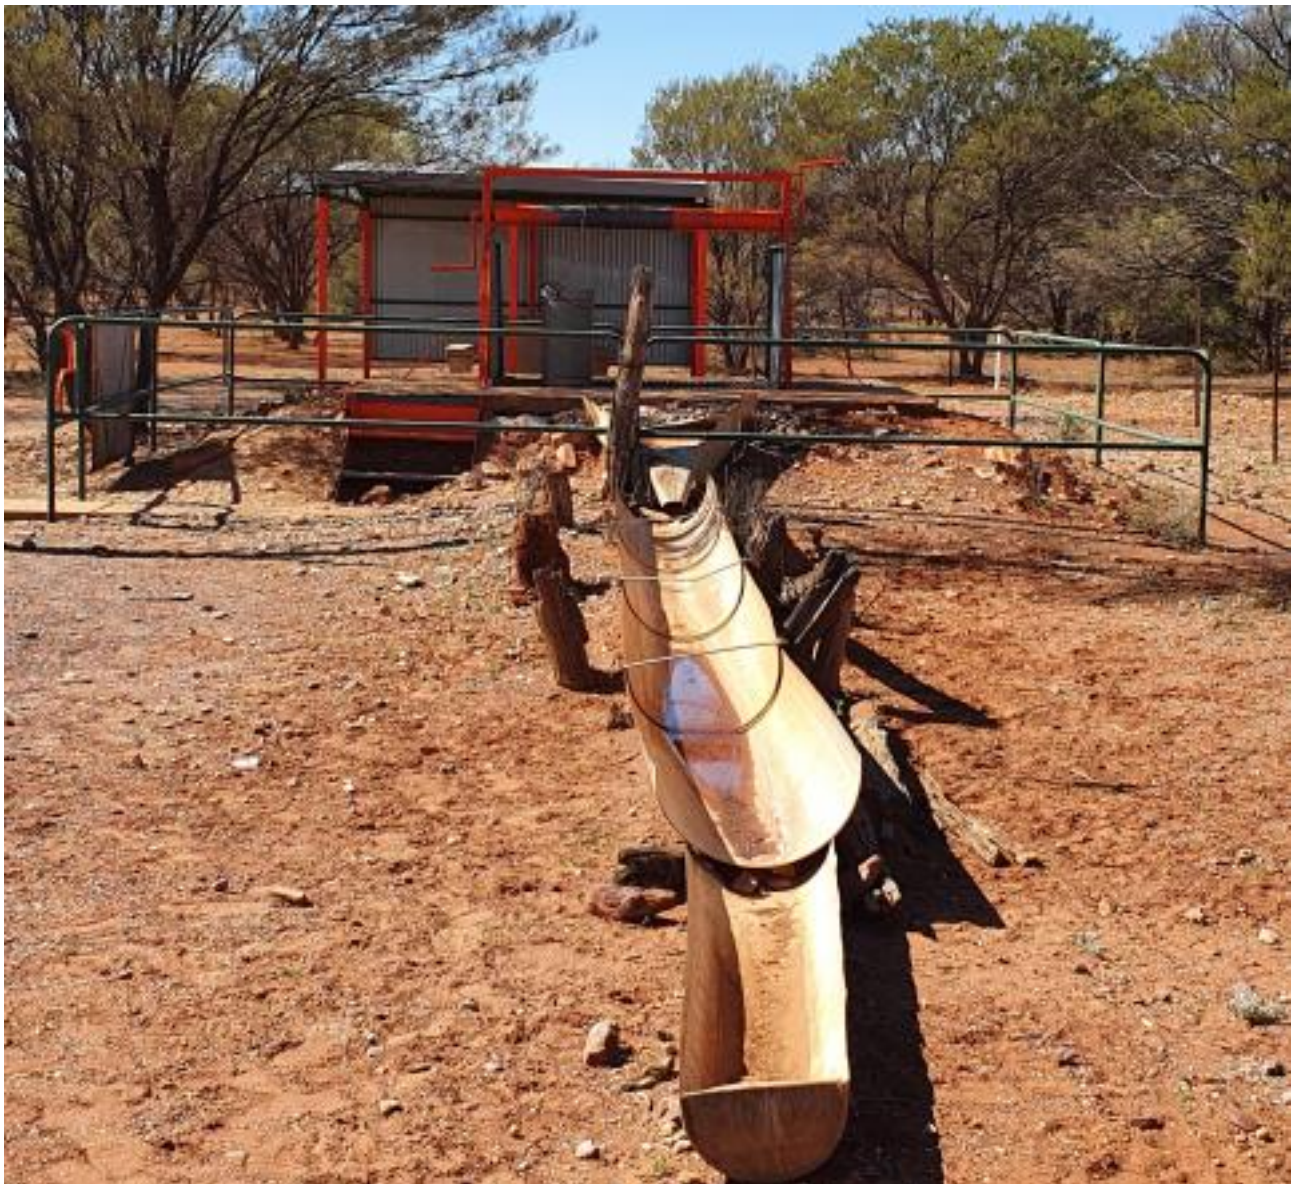
Well 5

Restored in good repair. Covered shelter & picnic bench, large camp area, gravel/stone base, track to Granite Peaks not well sign posted

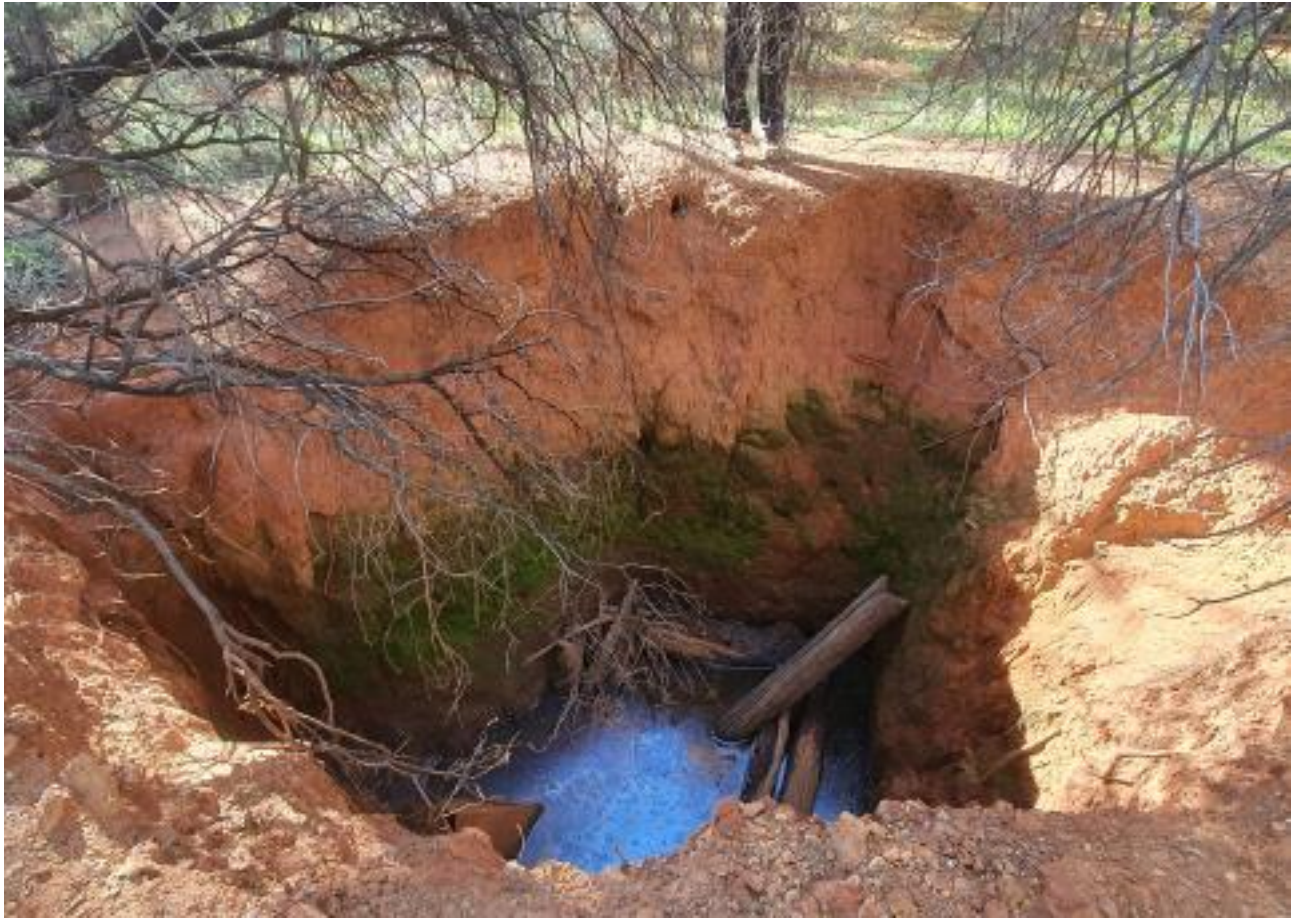
Unmaintained, good camp area, low tree cover providing ample shade.

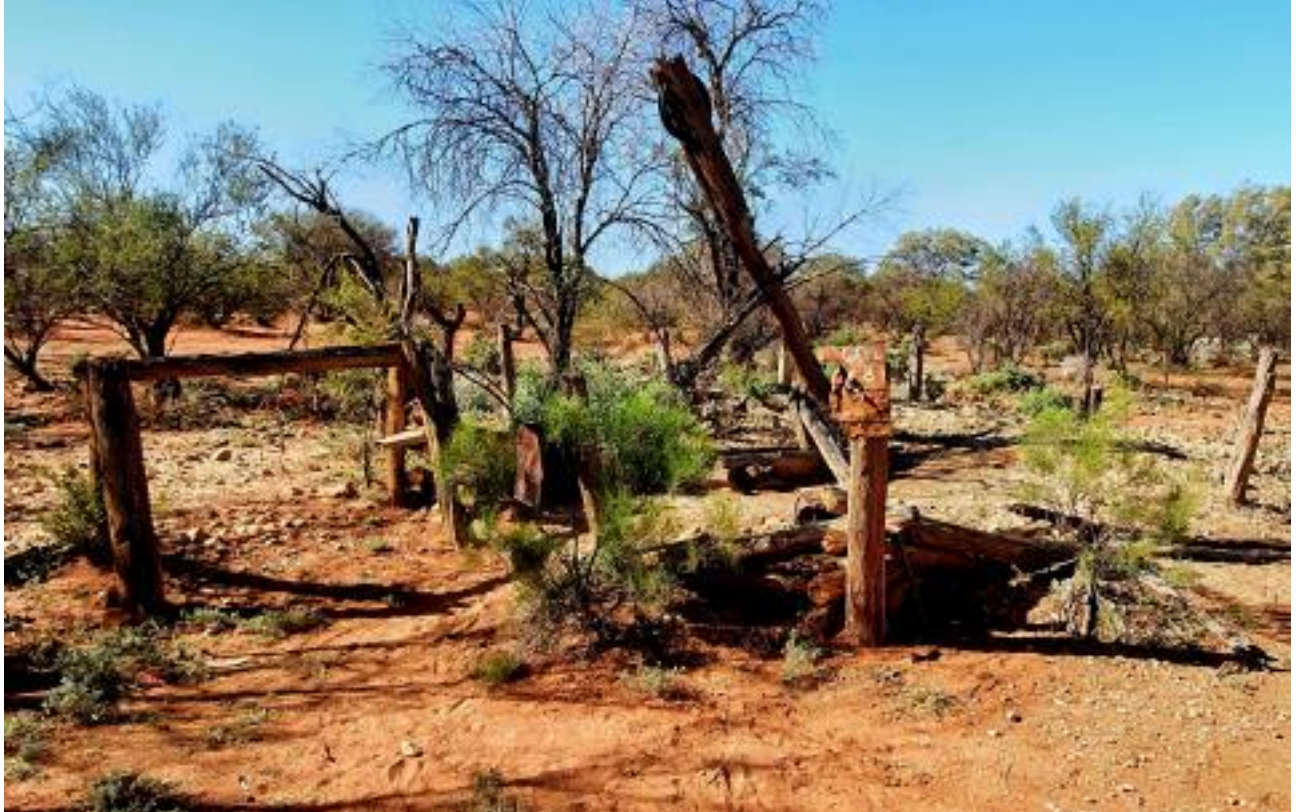
Well 8 Kunpa

Unmaintained. Camp area, partial shade, low trees/scrub, Ground sand based.

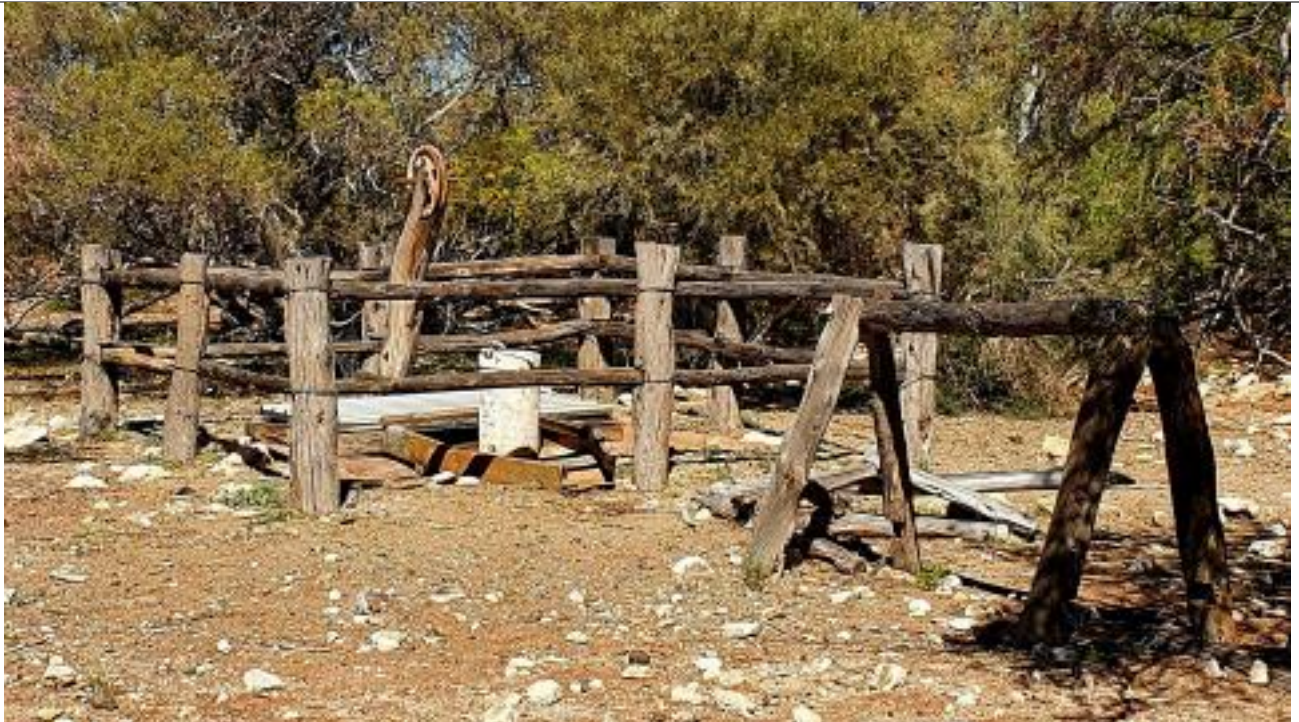
Well 9 Palatji, Weld Spring Lat. -25.017402 Long. 121.586342

Restored but in poor condition. Covered over, bore & tank for cattle, John Forrest's Hut, information display shelter, large flat area, Ground/sand base, Paperbark and scrubby area

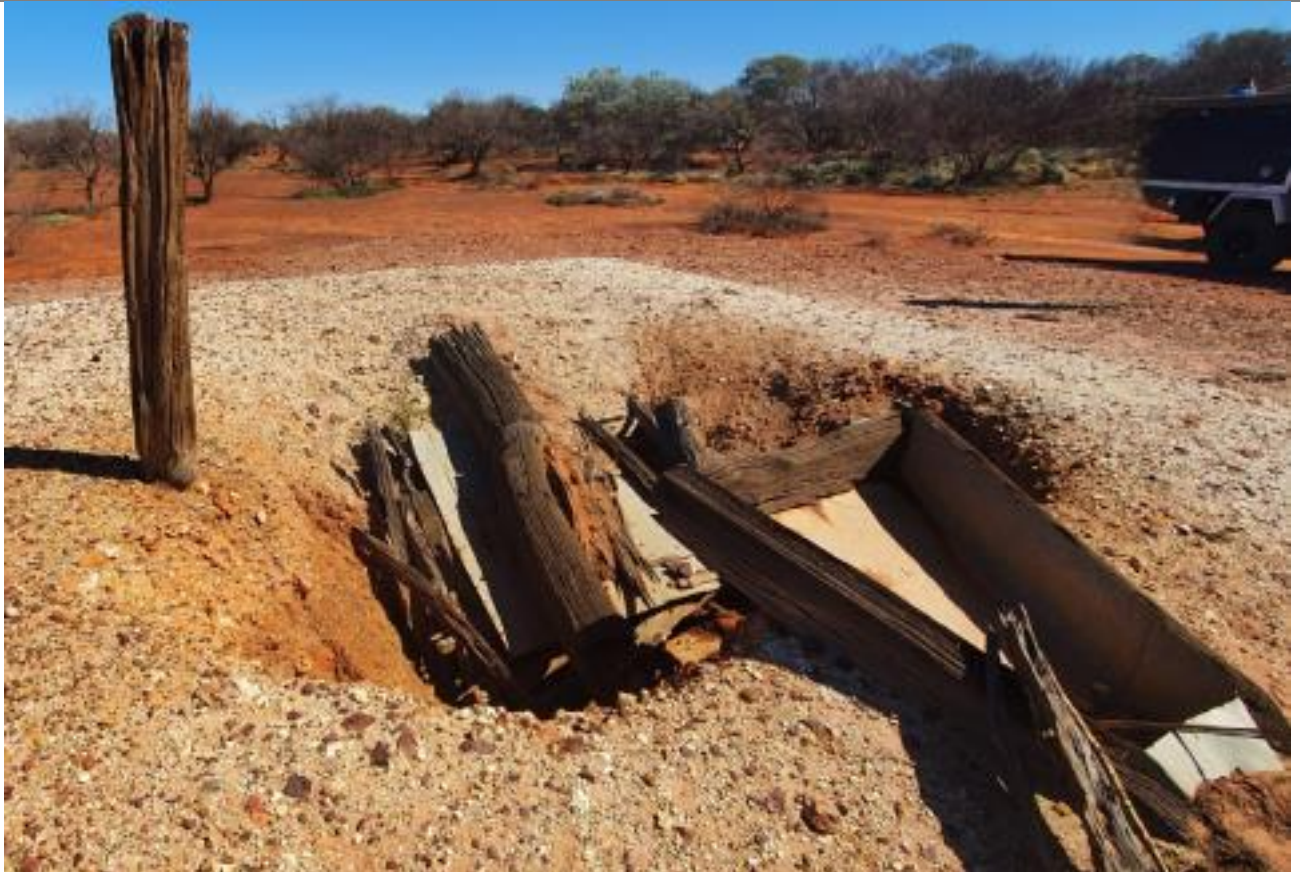
Well 10 Lucky Well

Unmaintained, little shade, large flat area, medium wetland on edge of area, sand based.

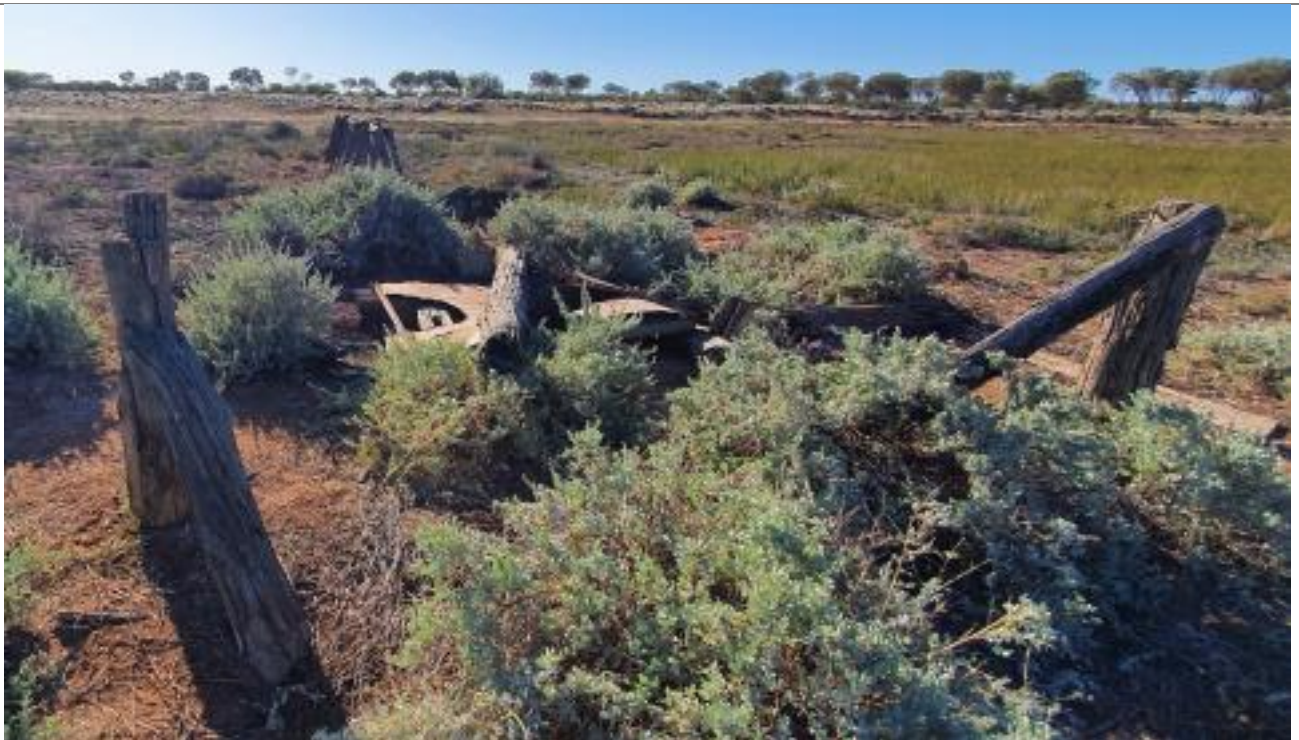
Well 11 Panju, Goodwin Soak, Lat. -24.749184 Long. 121.733995

Unmaintained. Notice to travellers sign unreadable, large area to camp, very open, no tree coverage in well area.

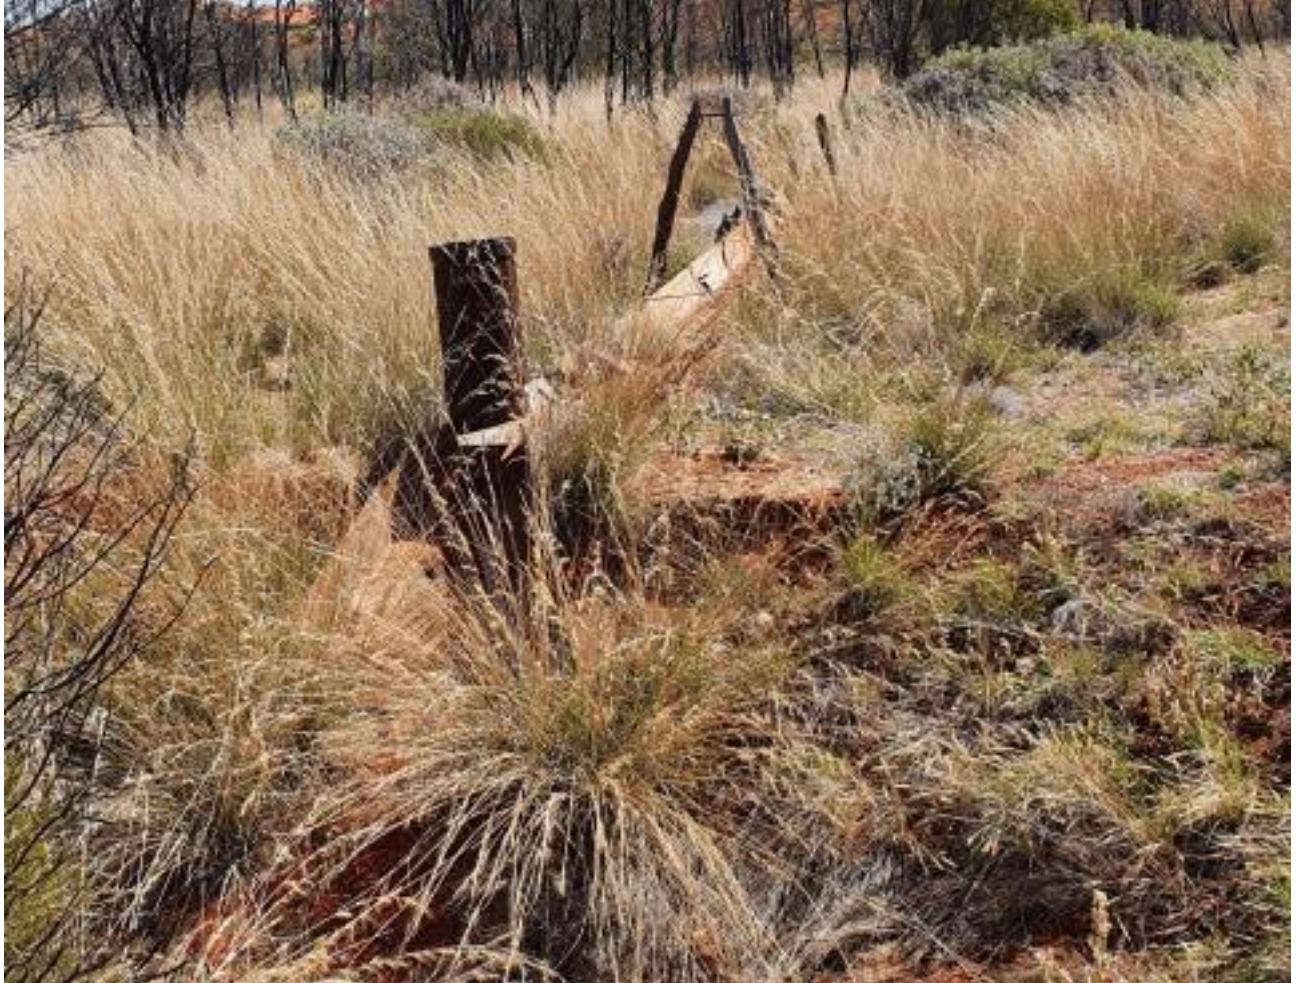
Unmaintained. Large camp area, lots of Spinifex. Poor signage.

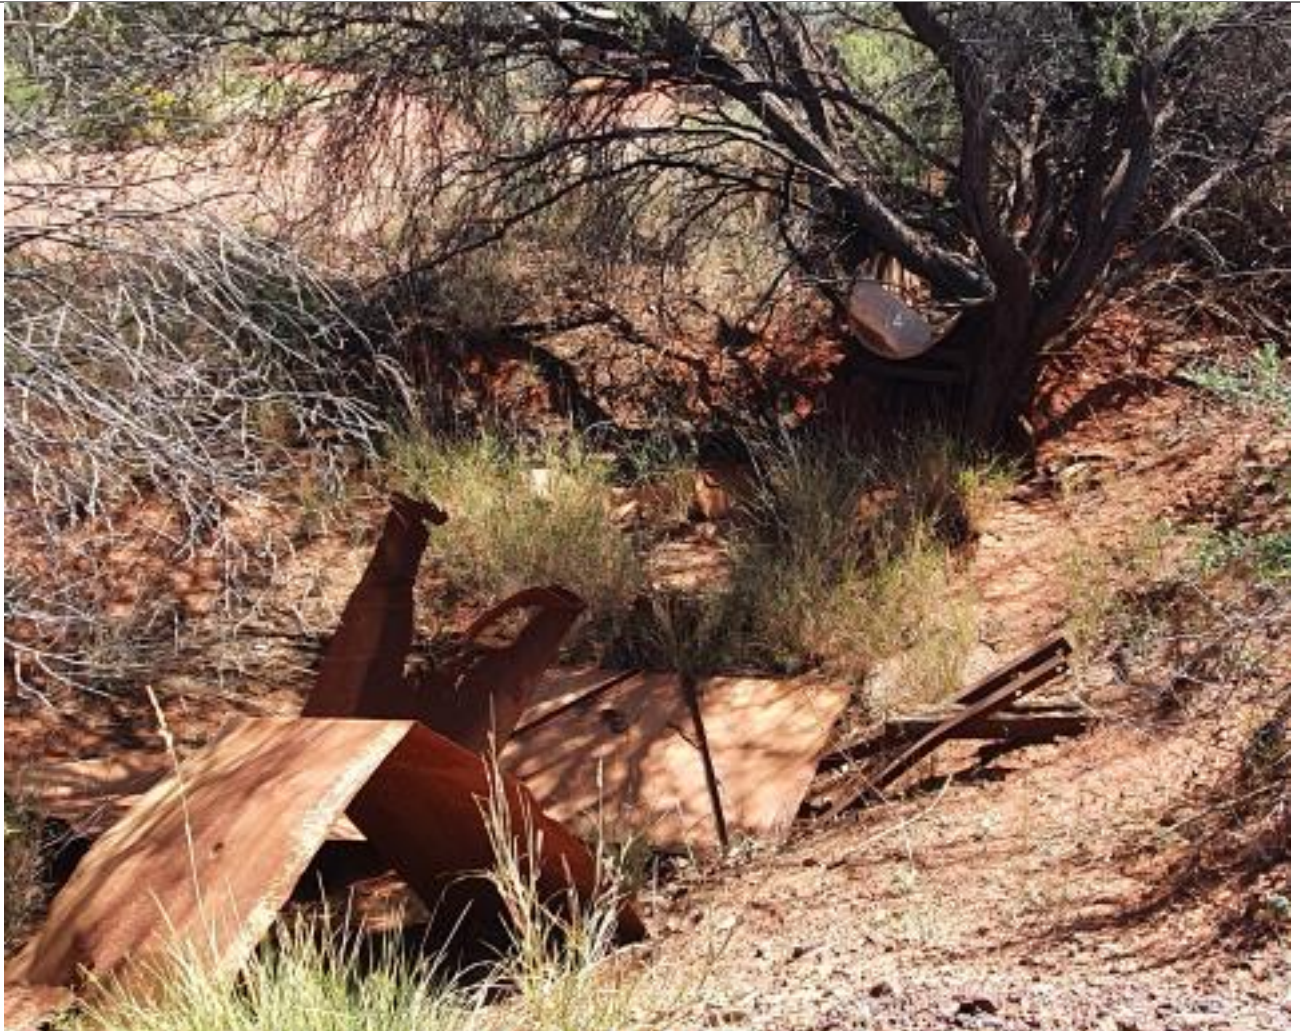
Well 14, Jintjimal

Unmaintained. Poor signage. Memorial to Kevin Albert Weckert & book, med size area to camp, ground sand based and lots of Spinifex.

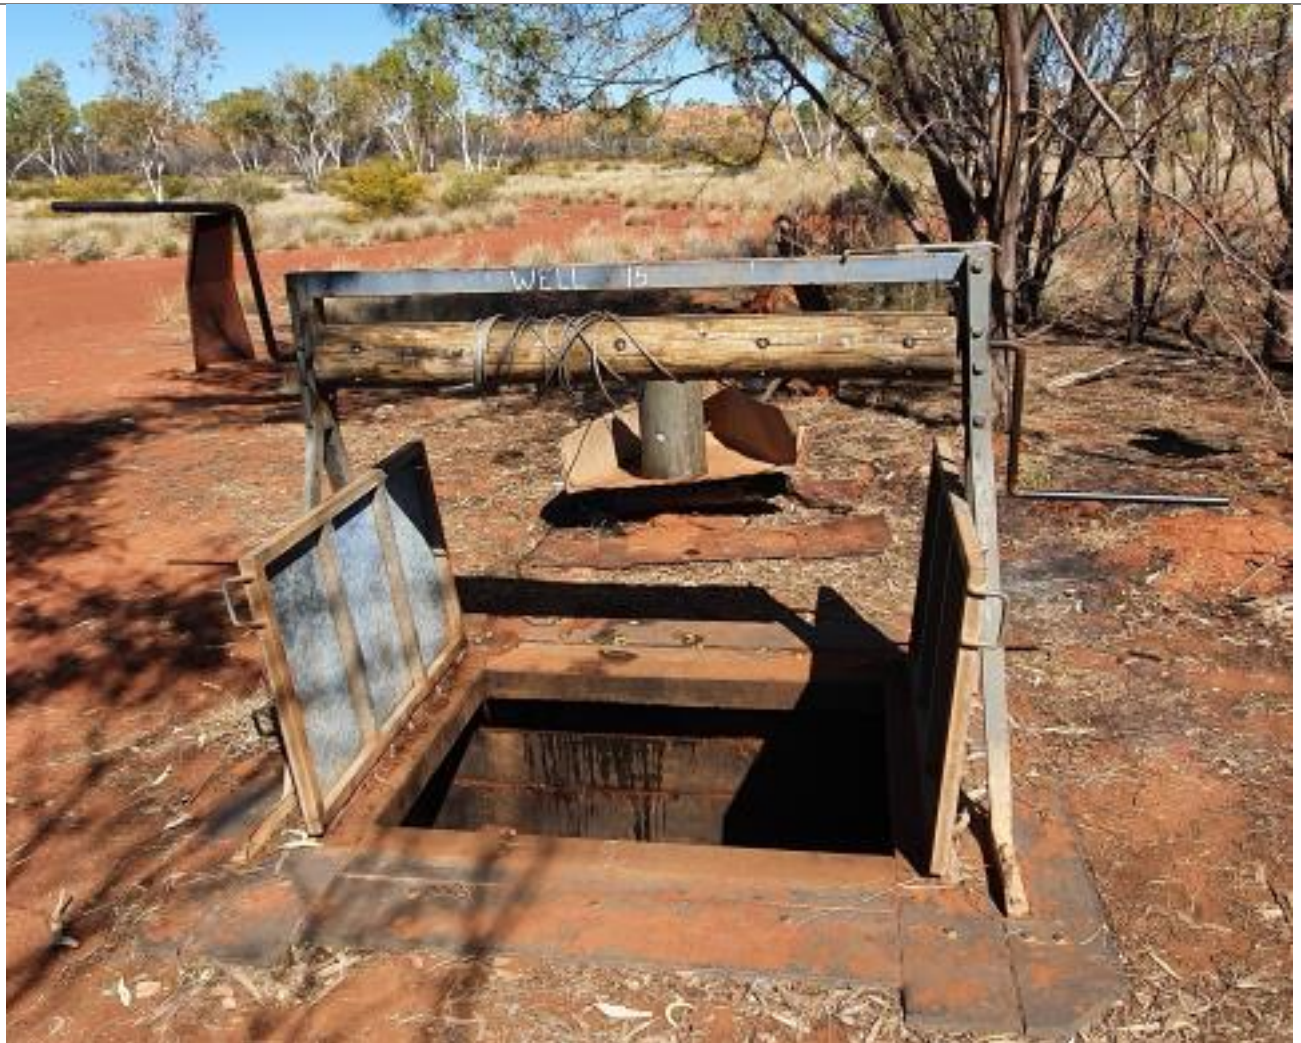
Well 15, Manjanka

Restored. In good repair, plenty of water, toilet in good repair, toilet signs in good condition, unknown working condition of solar light, good camp area, dead camel nearby.

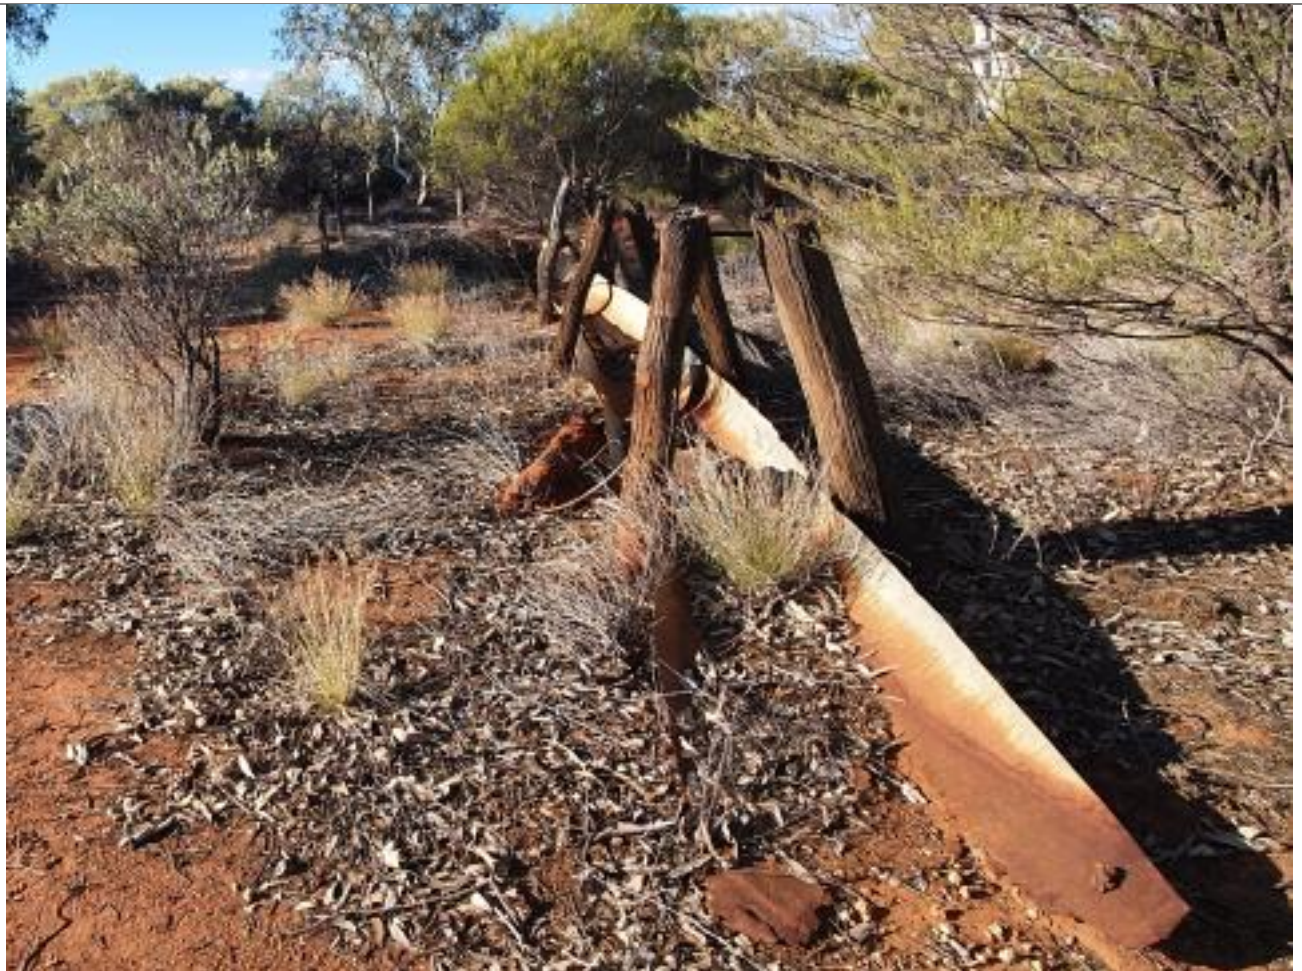
Well 16 Lawulawa

Unmaintained, no water. Good camp area, small quantity of shaded campsites, scenic, fair amount of spinifex.

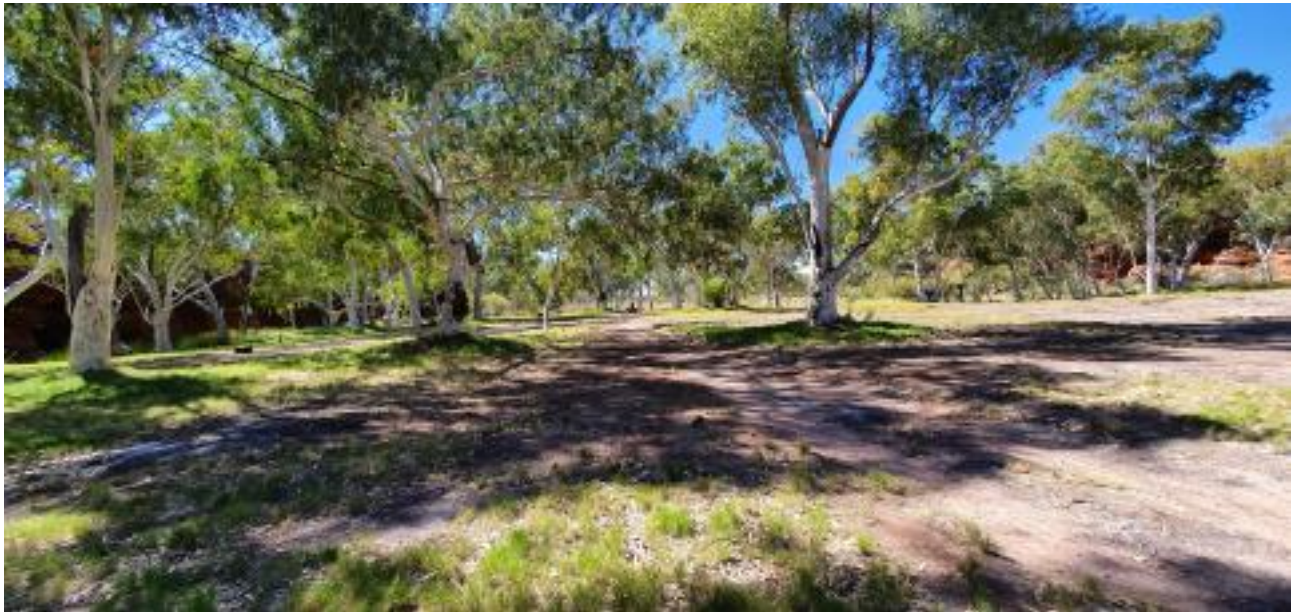
Durba Springs

Cleared grassed camping area with BBQ rings, toilet, donation box, sign shelter and lots of white gums for shade. Very popular spot.

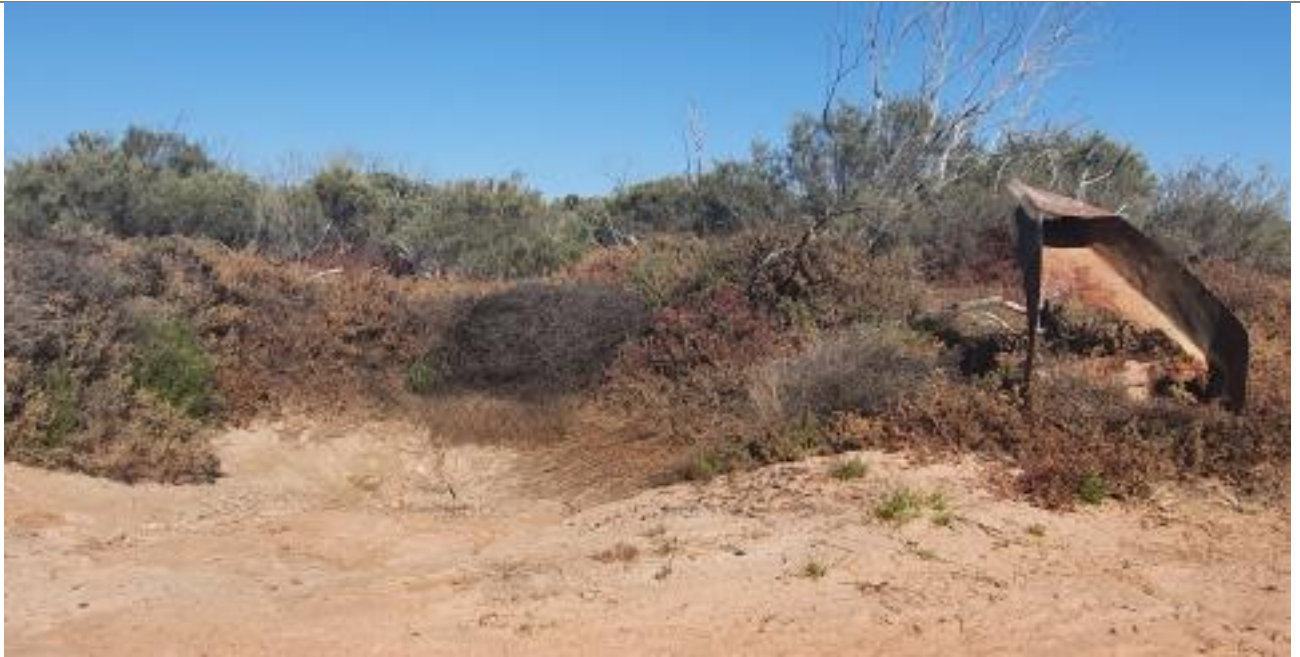
Unmaintained, dry small clean area to camp, clay ground base, medium vegetation on boundary of well area

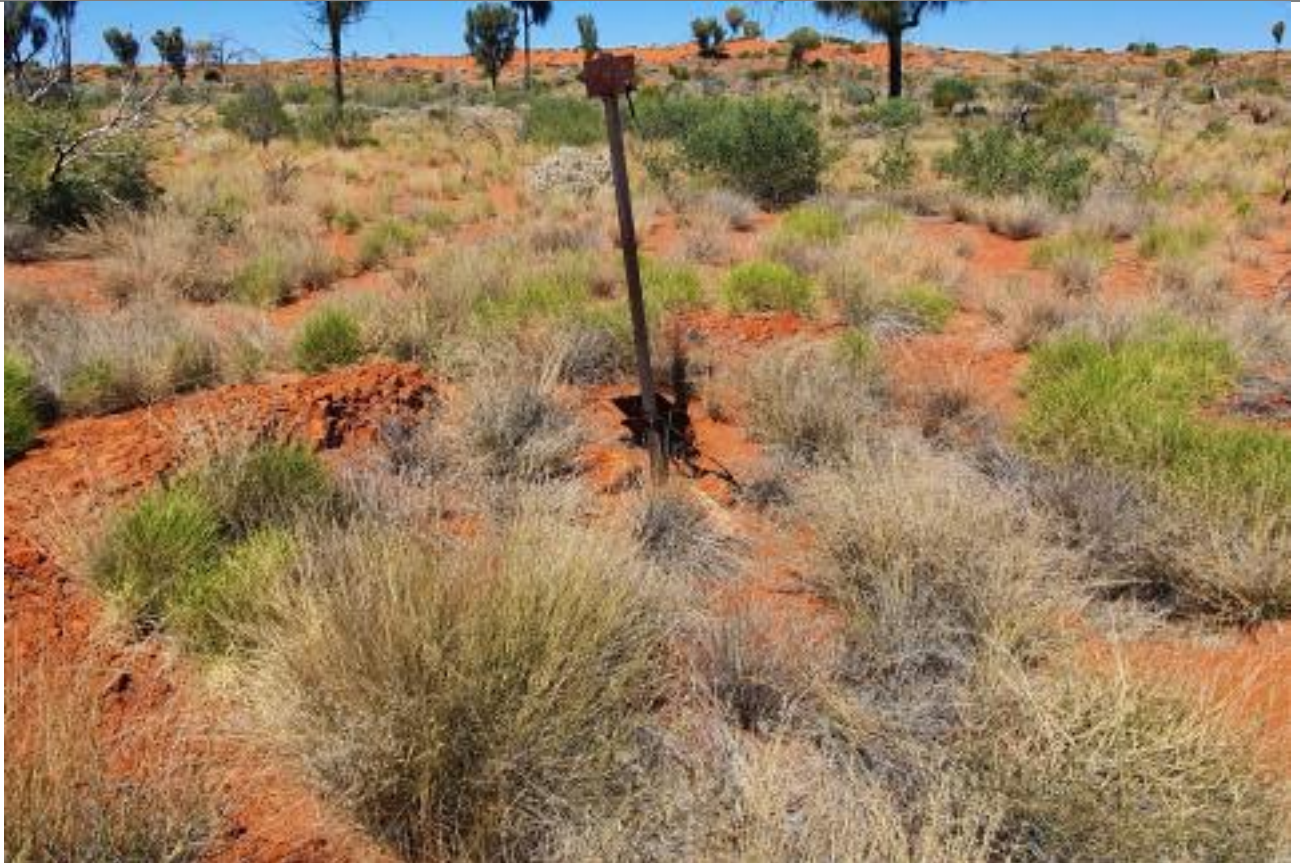
Well 20, Karanyal**Lat. -23.253749****Long. 122.596626**

Unmaintained, dry, few camp spots, some shade from Desert Oaks, sandy base.

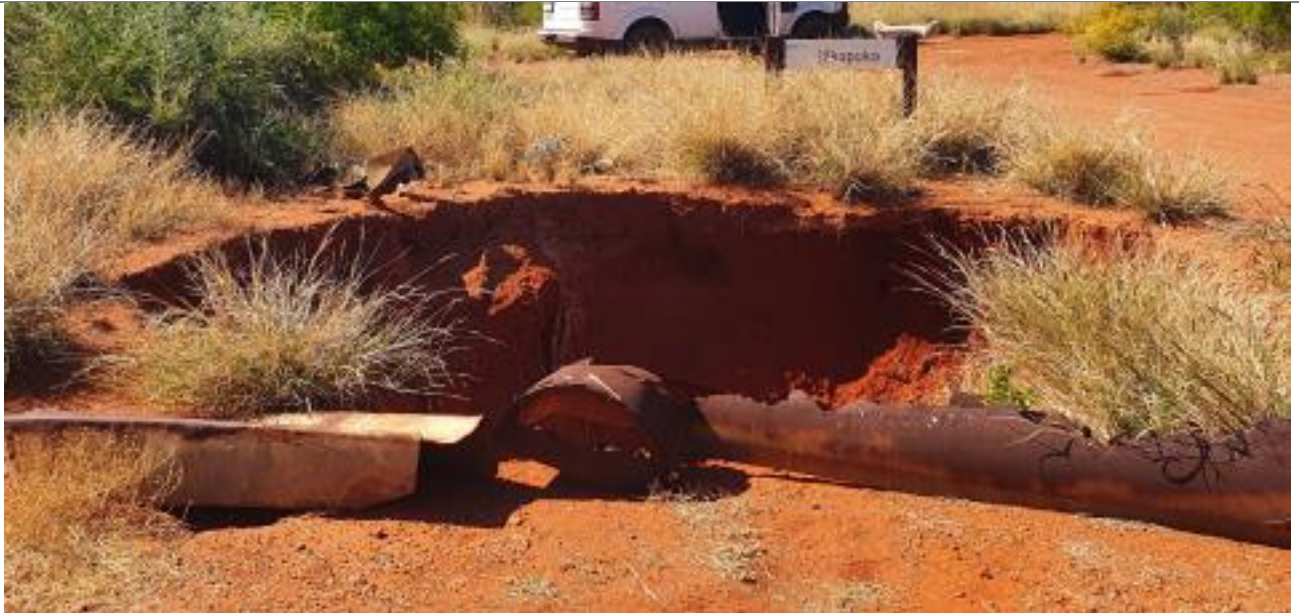
Well 21, Jilkupuka**Lat. -23.177494****Long. 122.809585**

Unmaintained, dry, no facilities, very small area

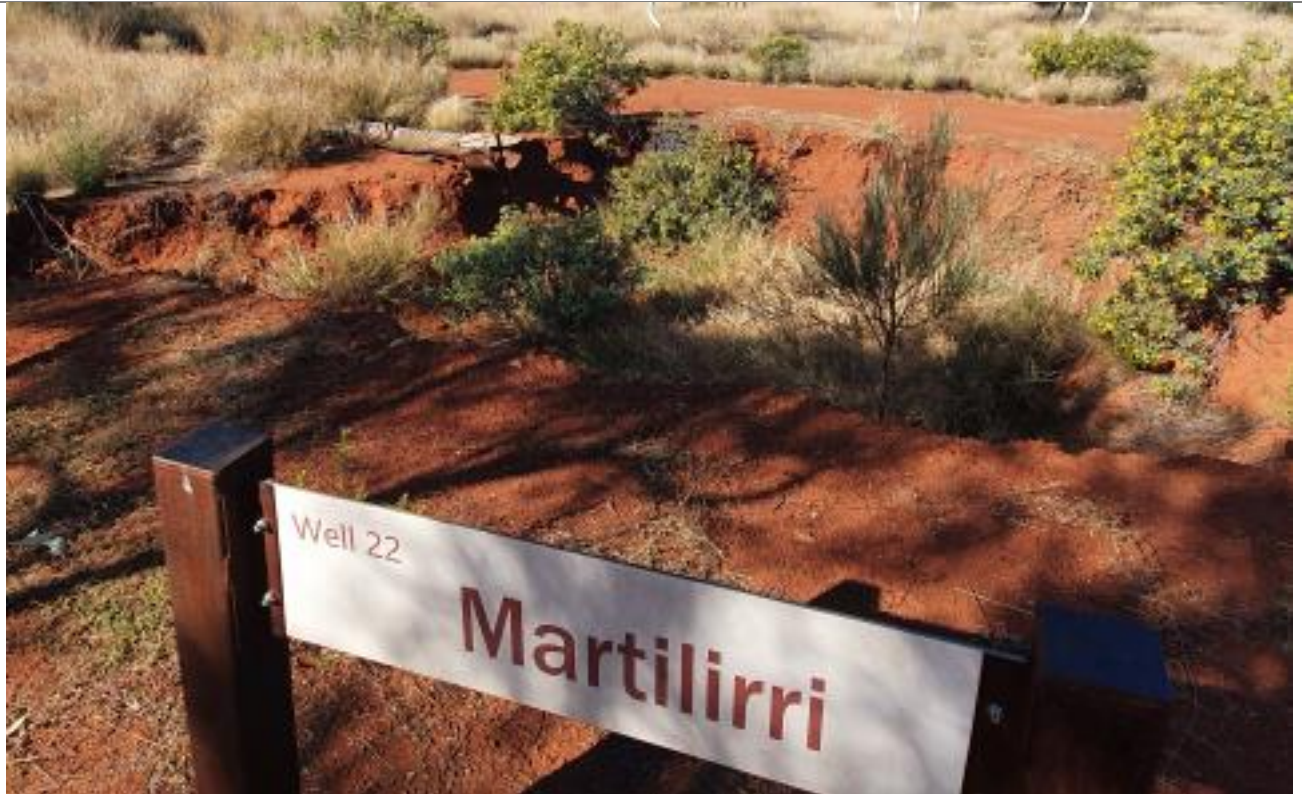
Well 22, Martilirri

DescriptionUnmaintained, dry, very small area to camp

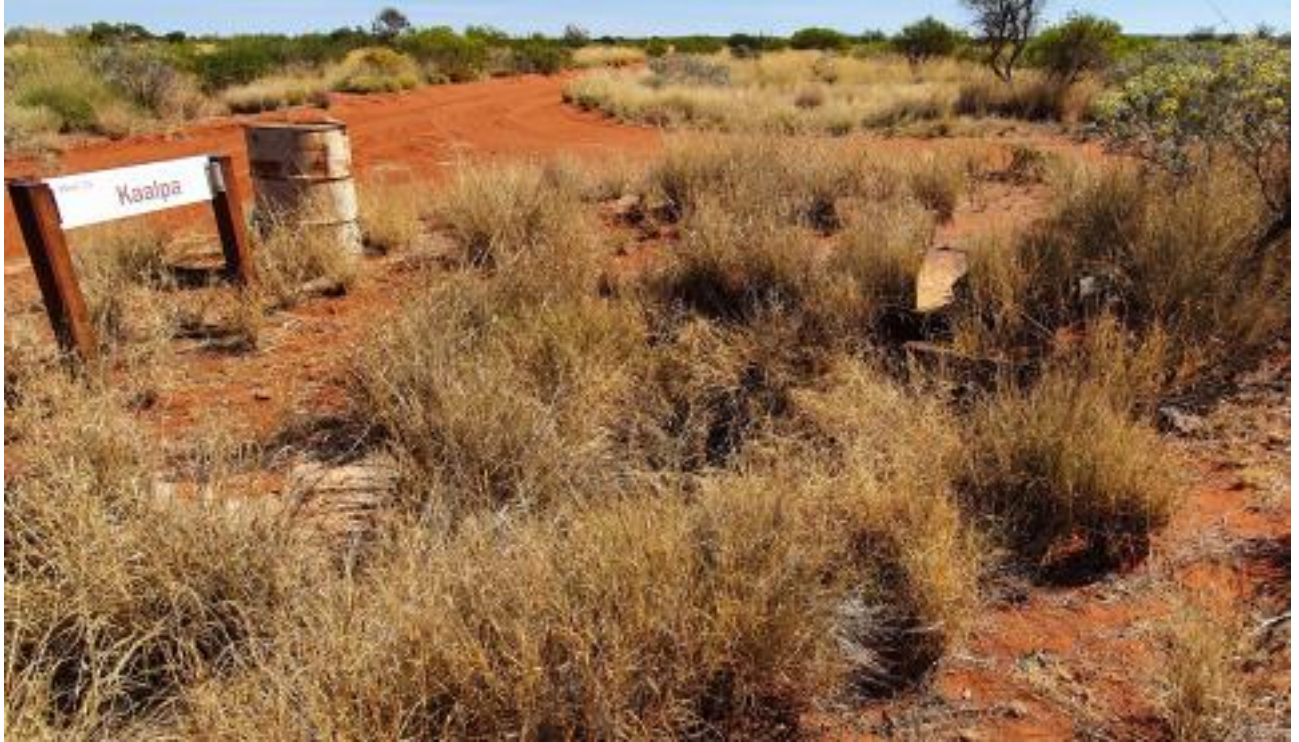
Unmaintained, dry, medium size camp area, sand base.
