Canning Stock Route Audit Report

Prepared for Track Care WA
Author: Rod Durston
August 2022

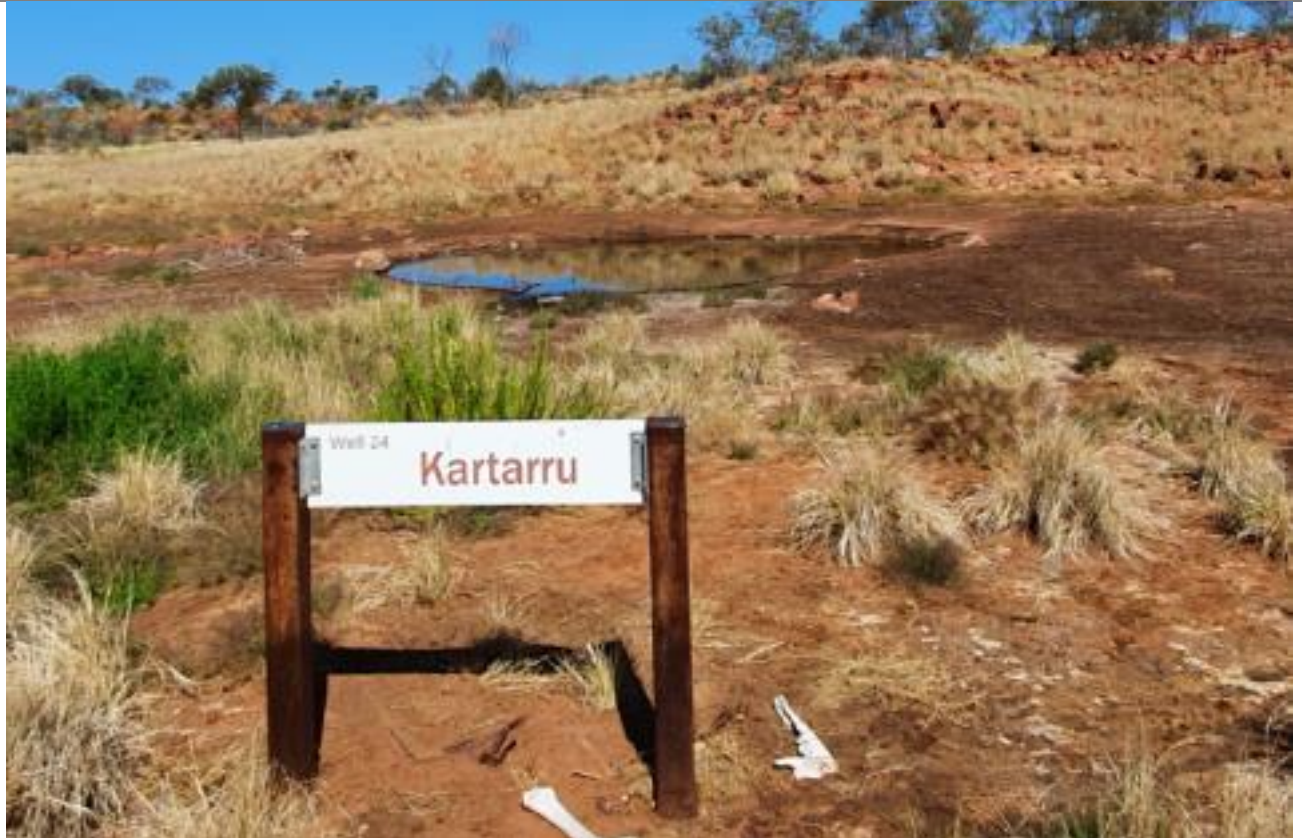
Well 24, Kartarru,**Lat. -23.109407****Long. 123.343596**

Unmaintained, filled in, small pool, no sign at track entrance, large open area to camp, no shade, low trees & scrub.

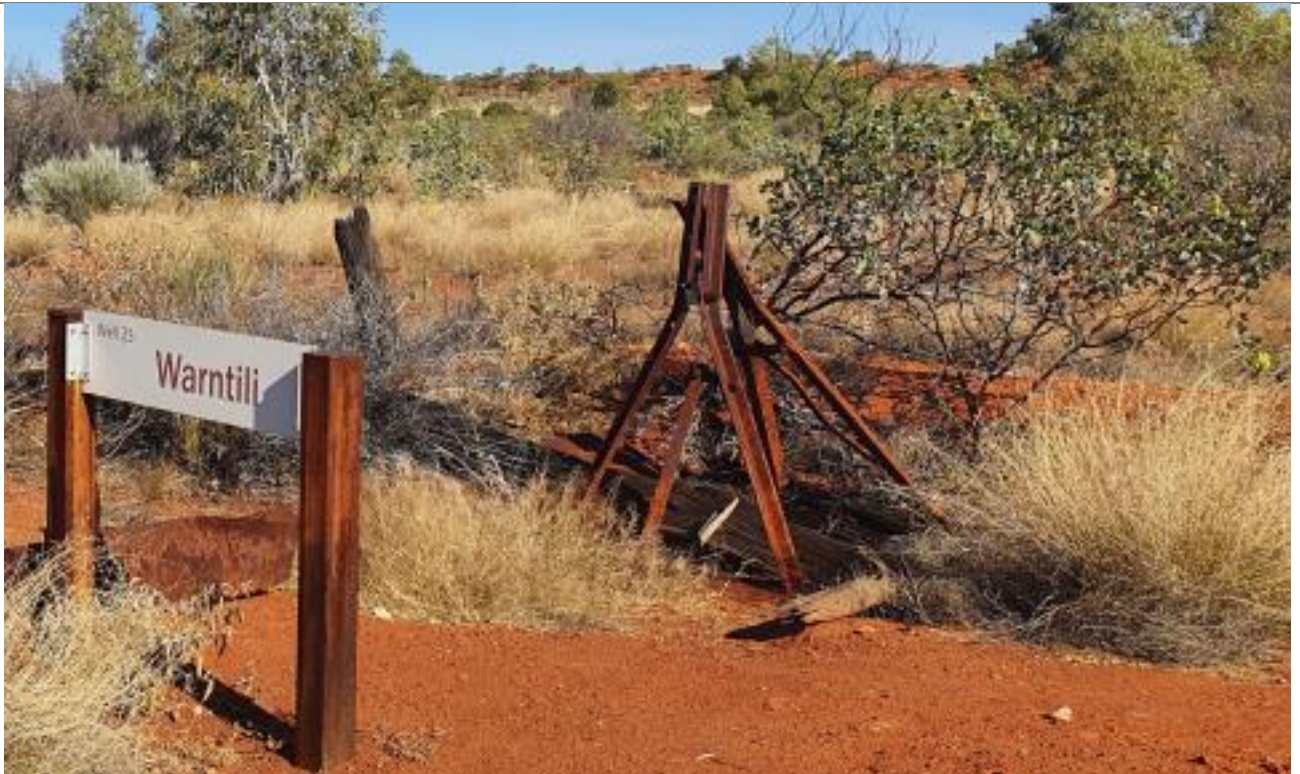
Unmaintained, dry, open & exposed area to camp

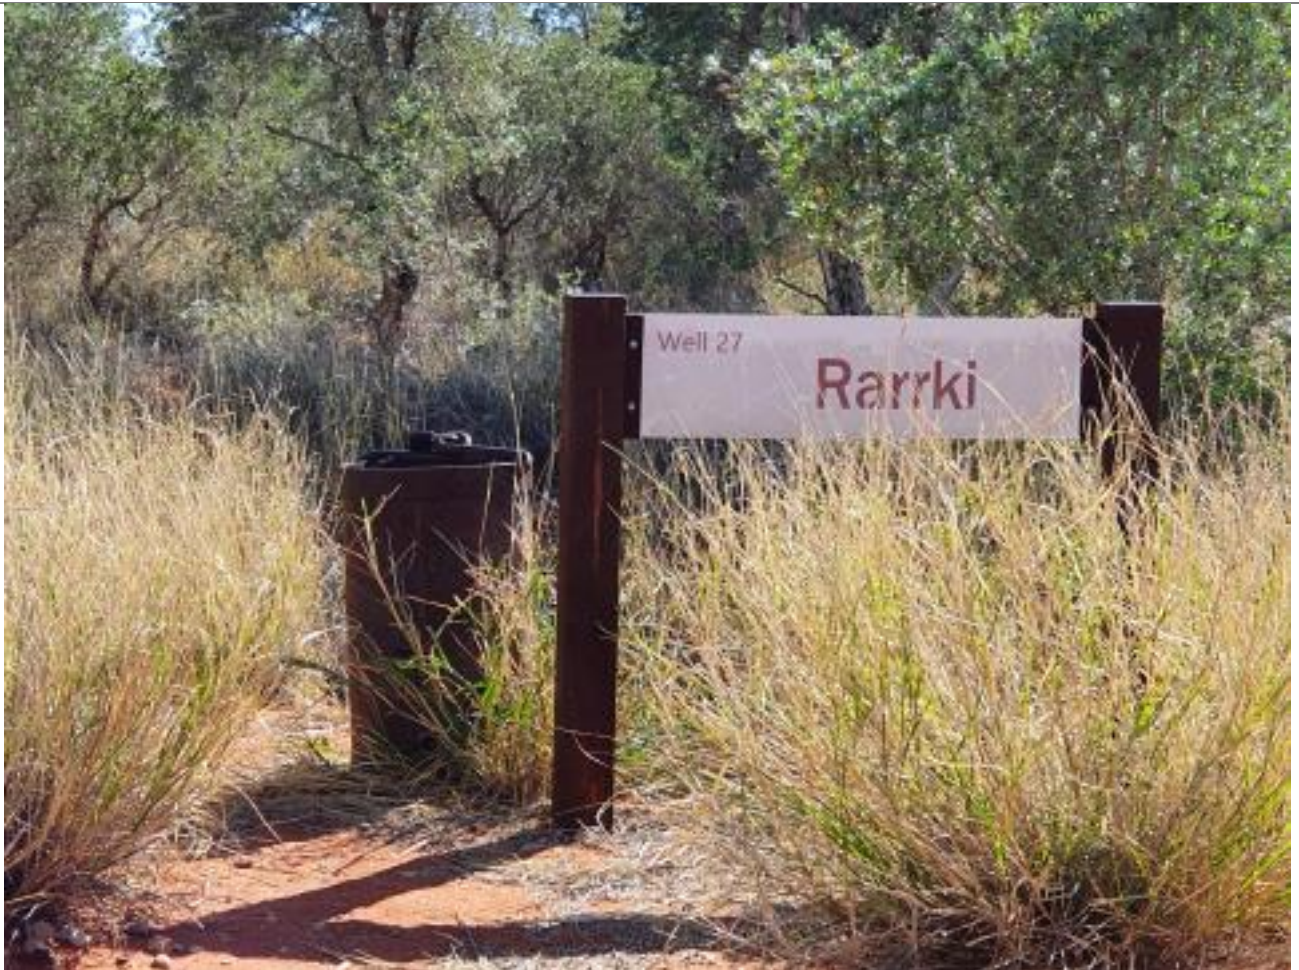
Well 27, Rarrki**Lat. -22.794751****Long. 123.644329**

Unmaintained, dry, Desert heath, Paperbark overstory, Buffel grass, small area to camp, sand base, little shade.

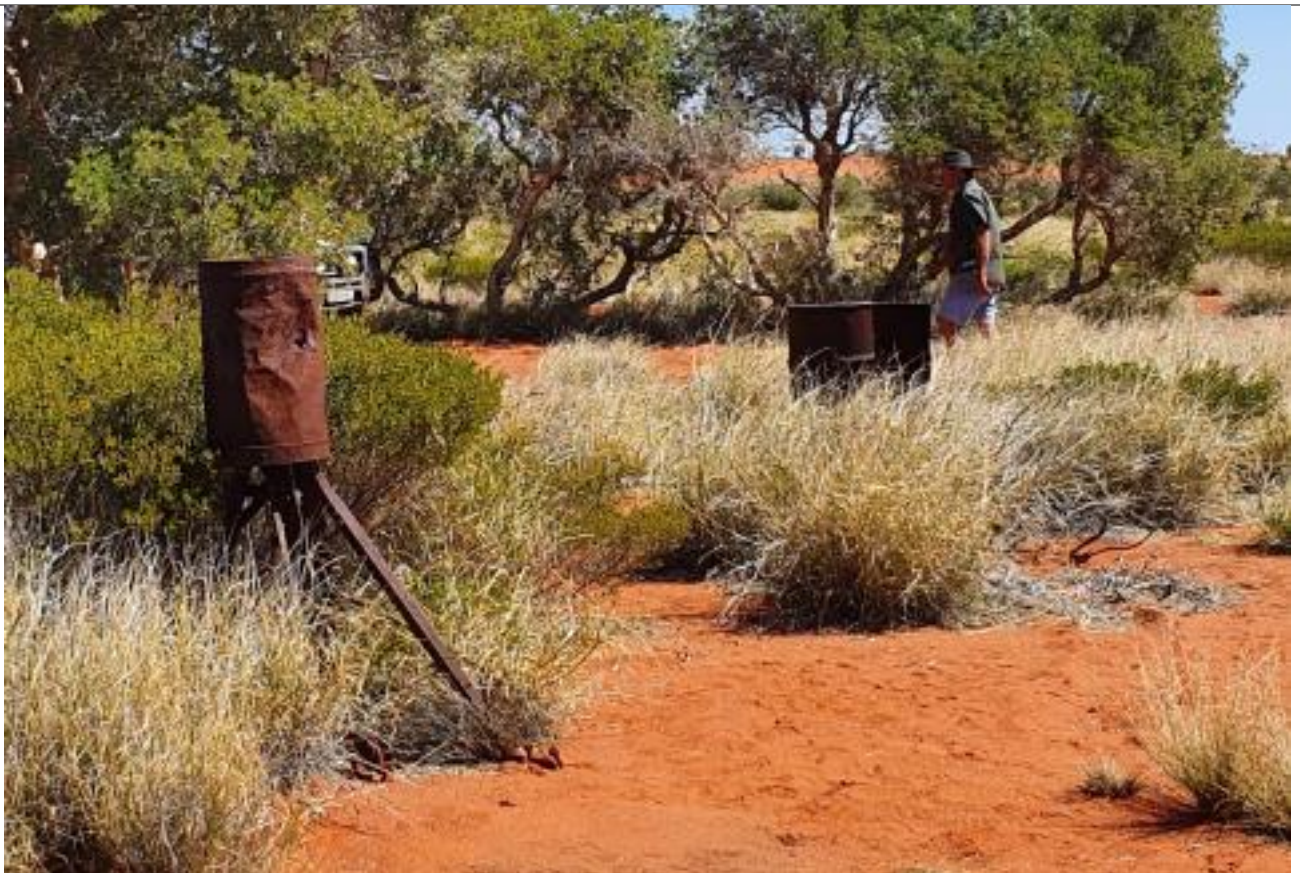
Well 28, Wuranu**Lat. -22.643374****Long. 123.757480**

Unmaintained, filled in. Signage poor, No28 scratched on side of well bucket. No CSR sign, medium size area to camp, small shade from 3-4 med size trees, low veg around perimeter, sand base.

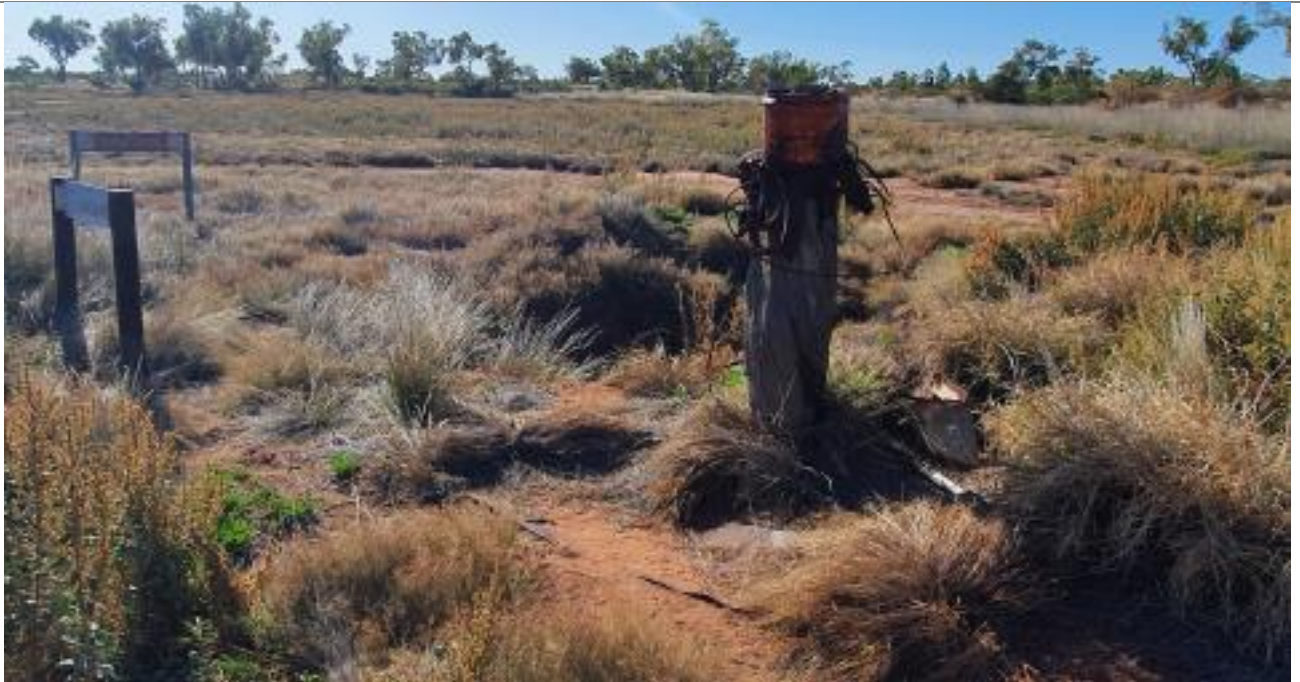
Well 30, Juntujuntu**Lat. -22.504175****Long. 124.139799**

Unmaintained, dry. Remains of blazed tree, no visible CSR sign, small area, ground sand base, Spinifex & Buffel grass. Mujingerra cave nearby with dead camel in it.

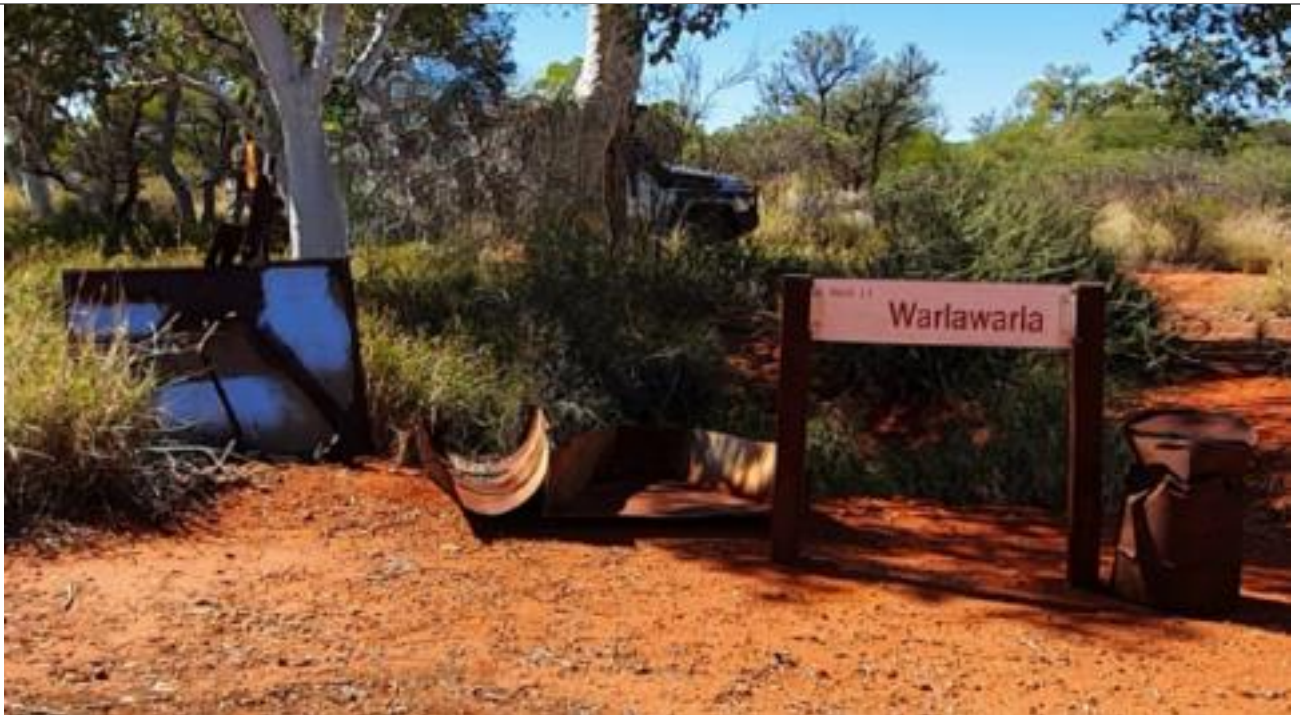
Well 31, Warlawarla**Lat. -22.525471****Long. 124.407188**

Unmaintained, filled in. Shade at well area, small camp area nearby, good camp site, Buffel grass.

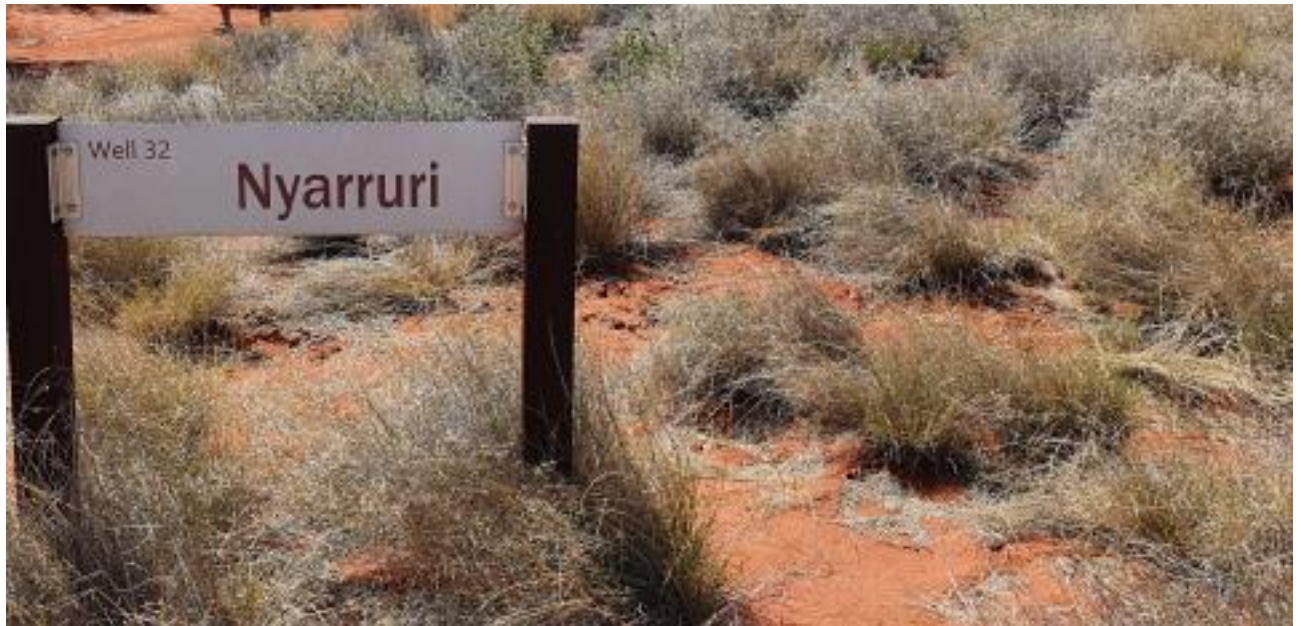
Well 32, Nyarruri,

Unmaintained, filled in. Open exposed area, Spinifex & Buffel grass, no camping area,

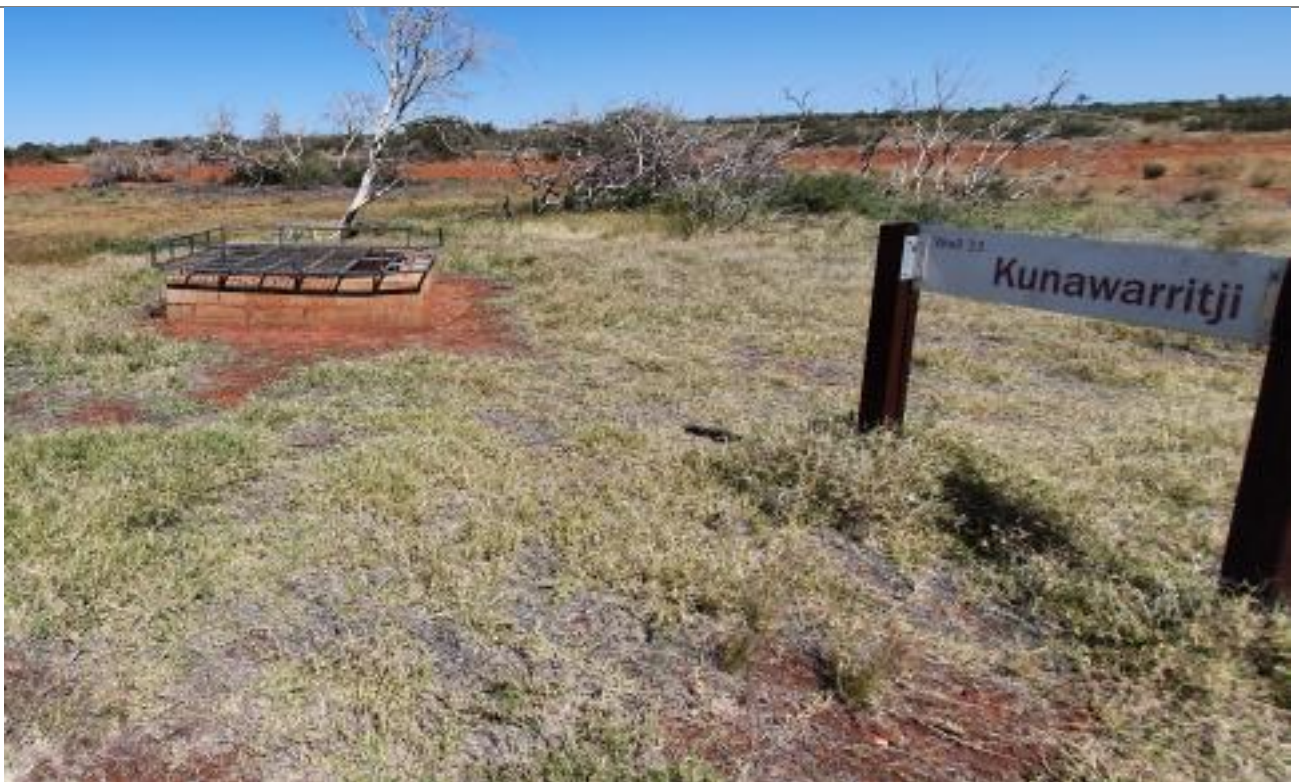
Well 33, Kunawarritji,**Lat. -22.341465****Long. 124.775219**

Well covered with metal rack, good bore water from tank, Toilet in good repair, solar light working. Waste dump point relocated to community waste site, requires new waste dump point sign, Large open exposed camp area, medium vegetation around perimeter.

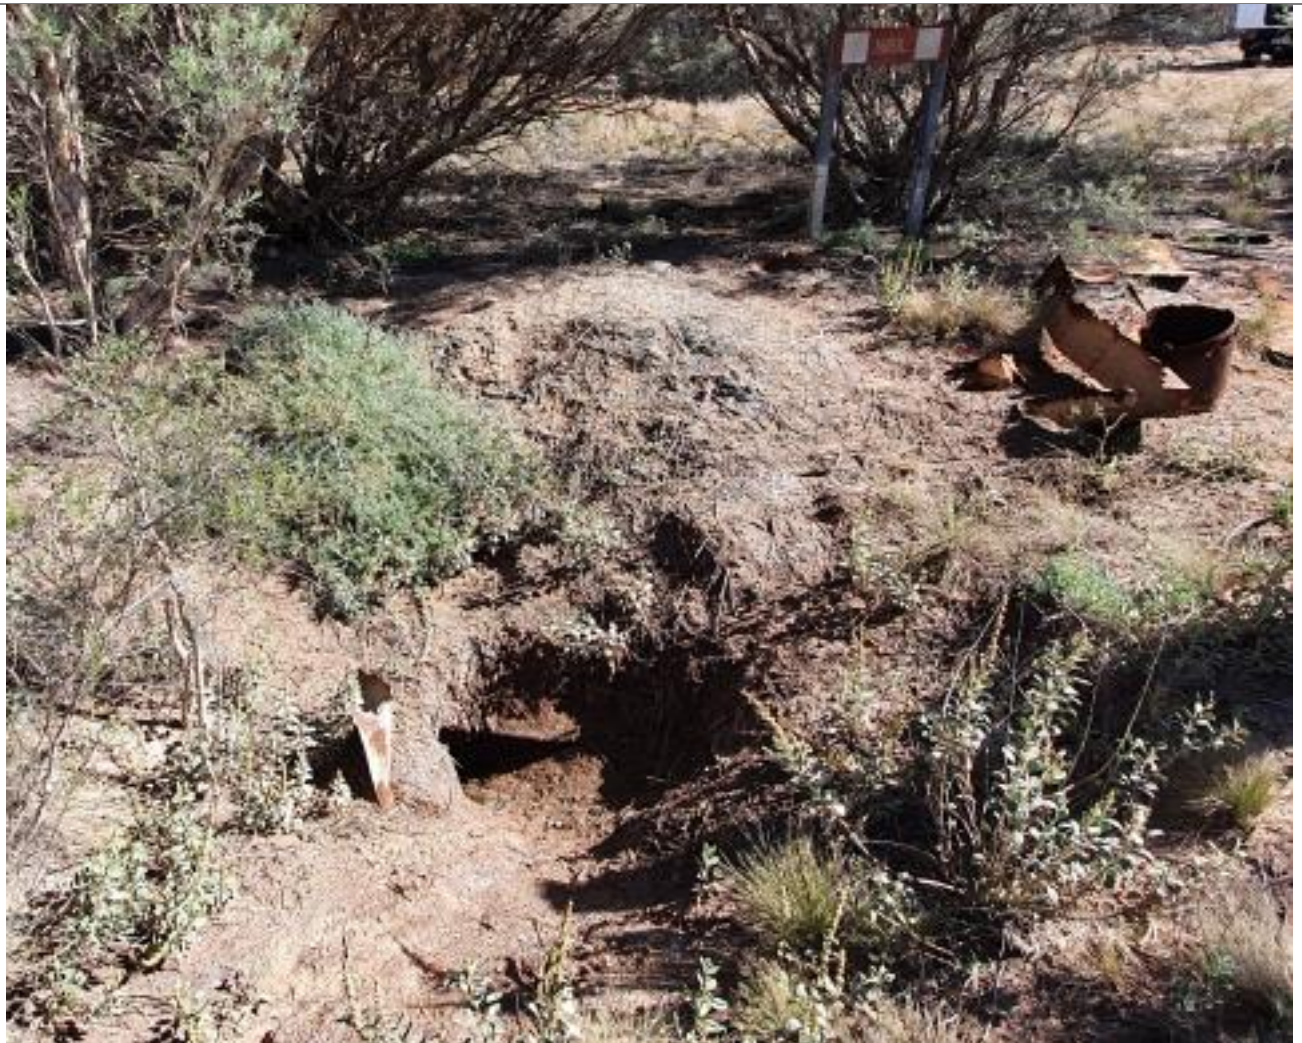
Well 34, Nyipily**Lat. -22.258718****Long. 124.902752**

Unmaintained, filled in. Very small area to camp, no shade.

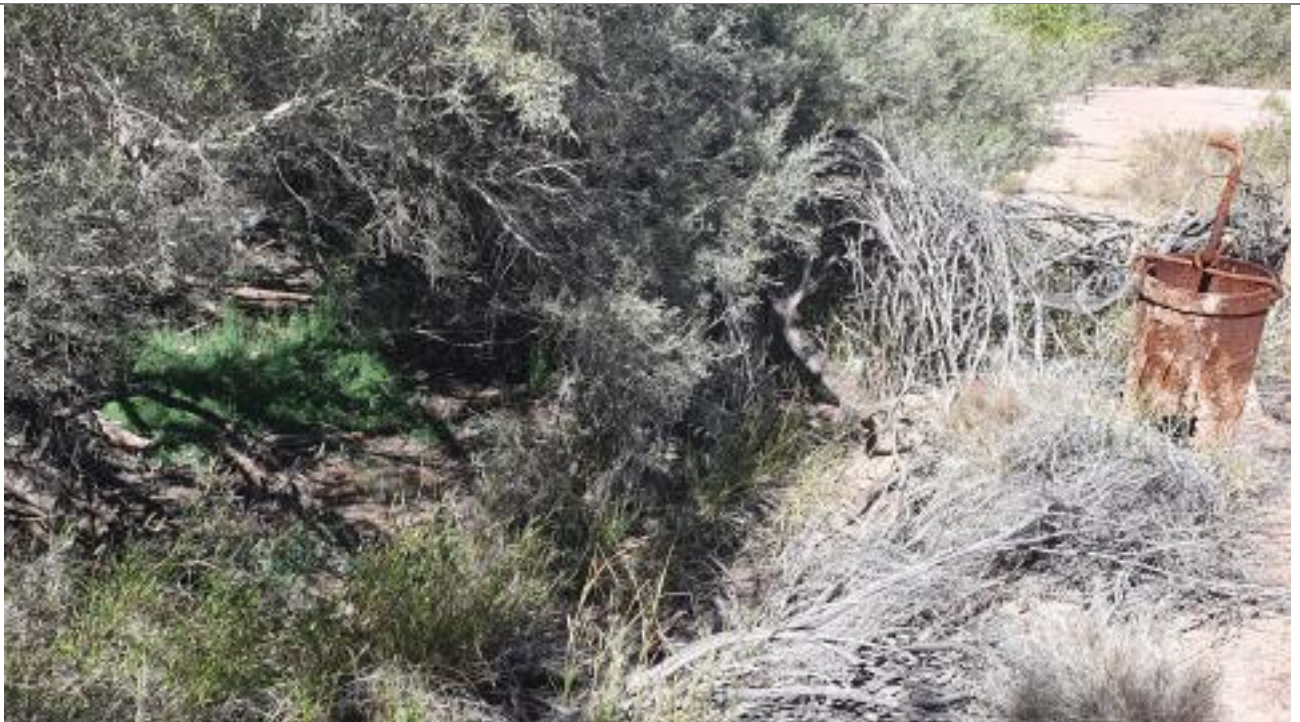
Well 35, Kinyu,**Lat. -22.213178****Long. 125.050668**

Unmaintained, dry, Poly pipe bore not found, good camp area, Buffel grass, sand base.

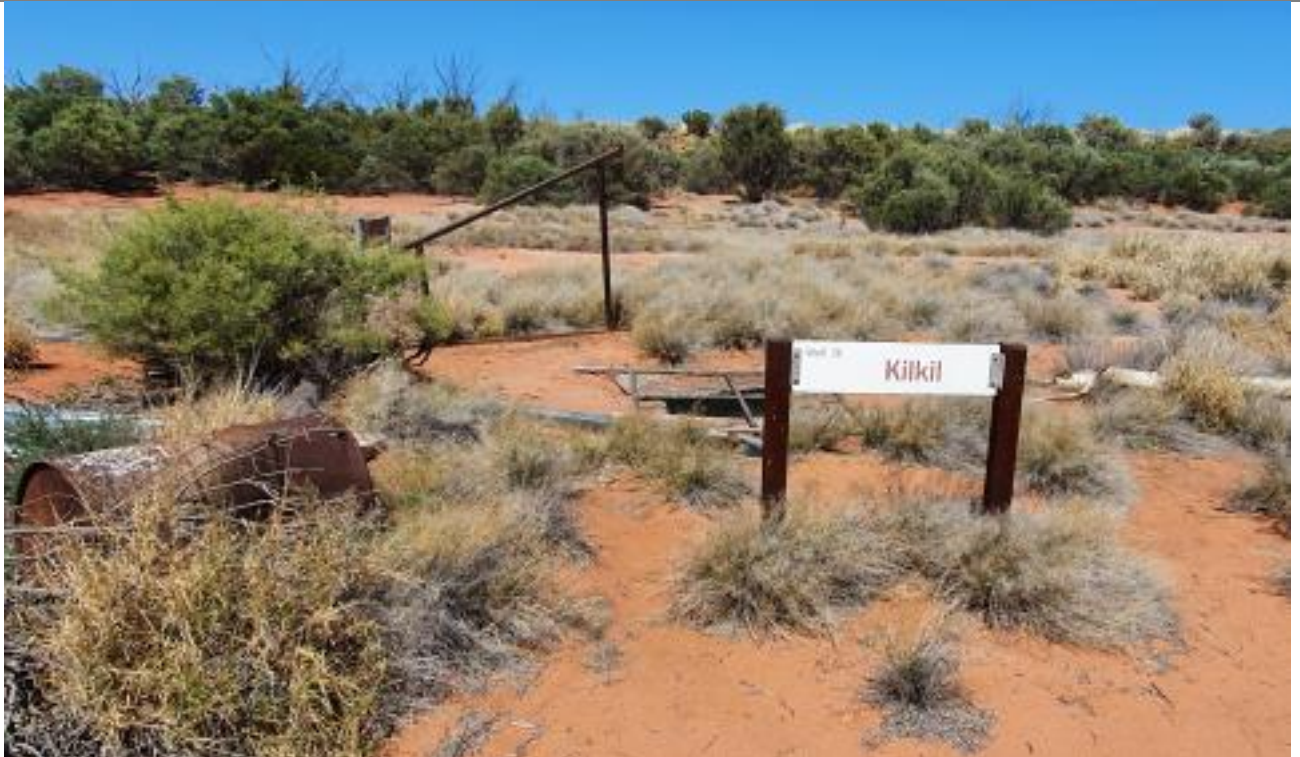
Well 36, Kilkil

Unmaintained, well covered with wire fence. Good med size camp area, some shade, Buffel grass, sand base.

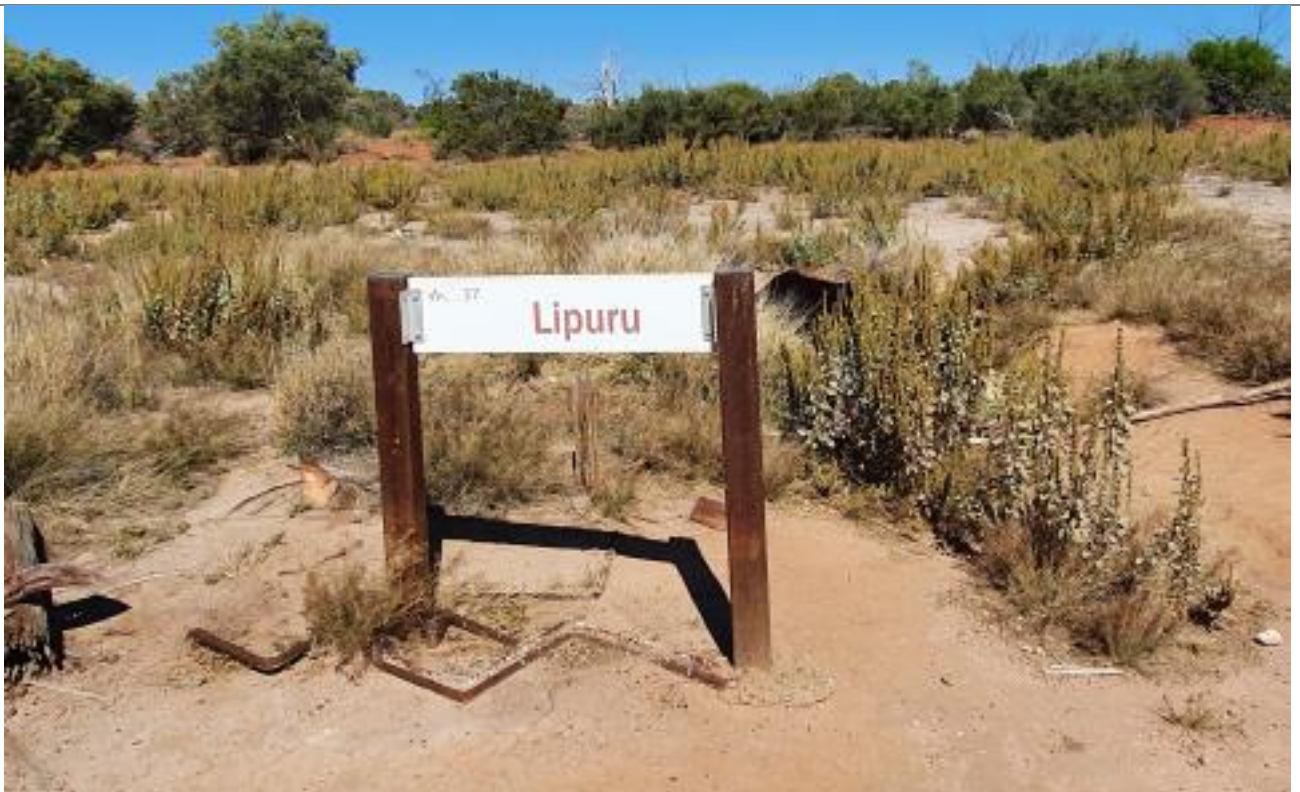
Well 37, Lipuru,**Lat. -22.154899****Long. 125.459080**

Unmaintained, dry. Well covered with section wire fence, Buffel grass, sand base, Replica of original grave markers in poor state of repair, Thompson, Shoemith & Chinaman graves not found.

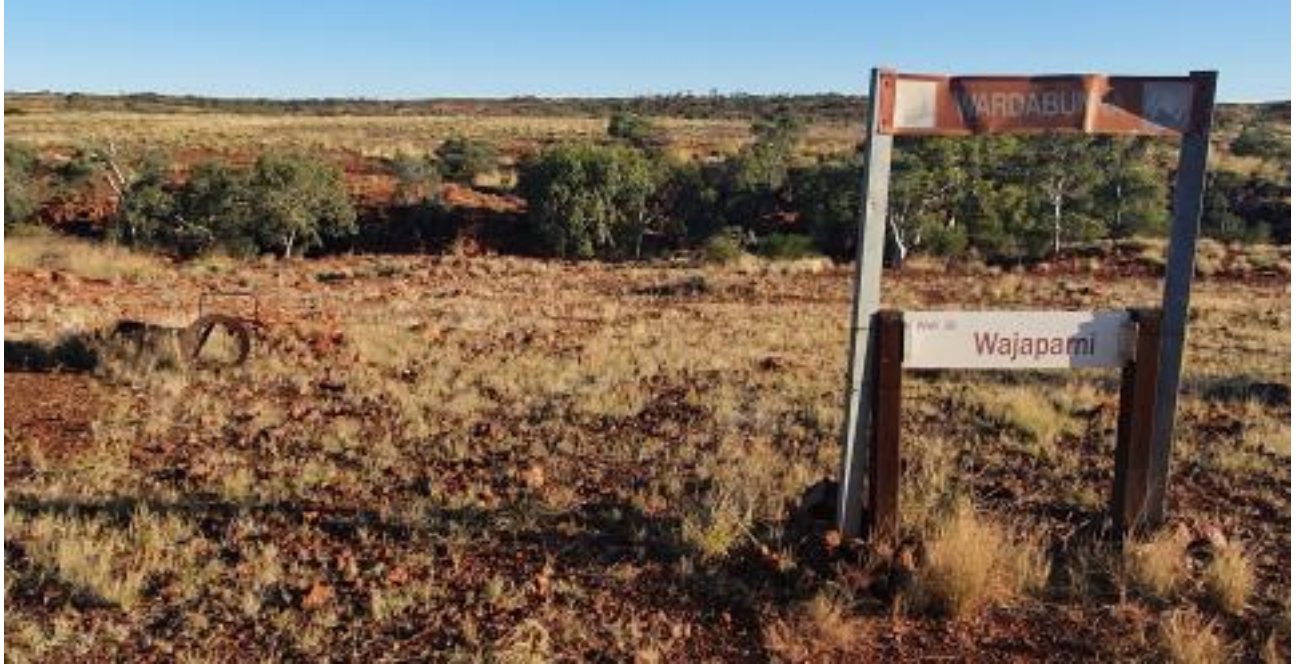
Well 38, Wajaparni

Dry creek, very exposed area, stony base, creek very scenic to explore, camp area to the West nearby.

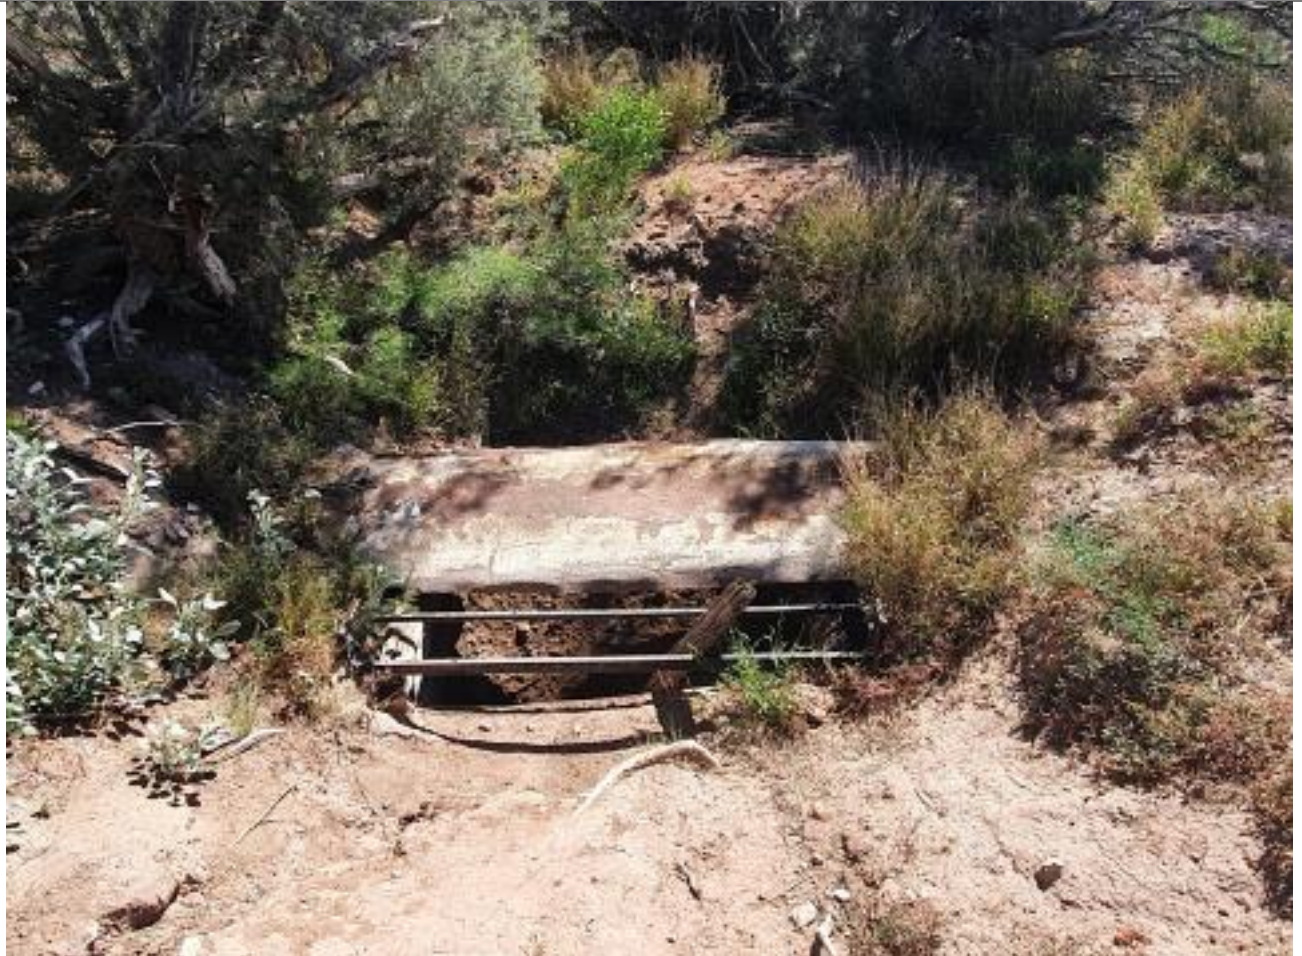
Well 39, Kukapanyu**Lat. -21.766954****Long. 125.651433**

Well partially covered with tin sheet, small amount of water. Exposed & open area, medium vegetation at well site only. Tufted grass/soft spinifex, original whip pole laying nearby.

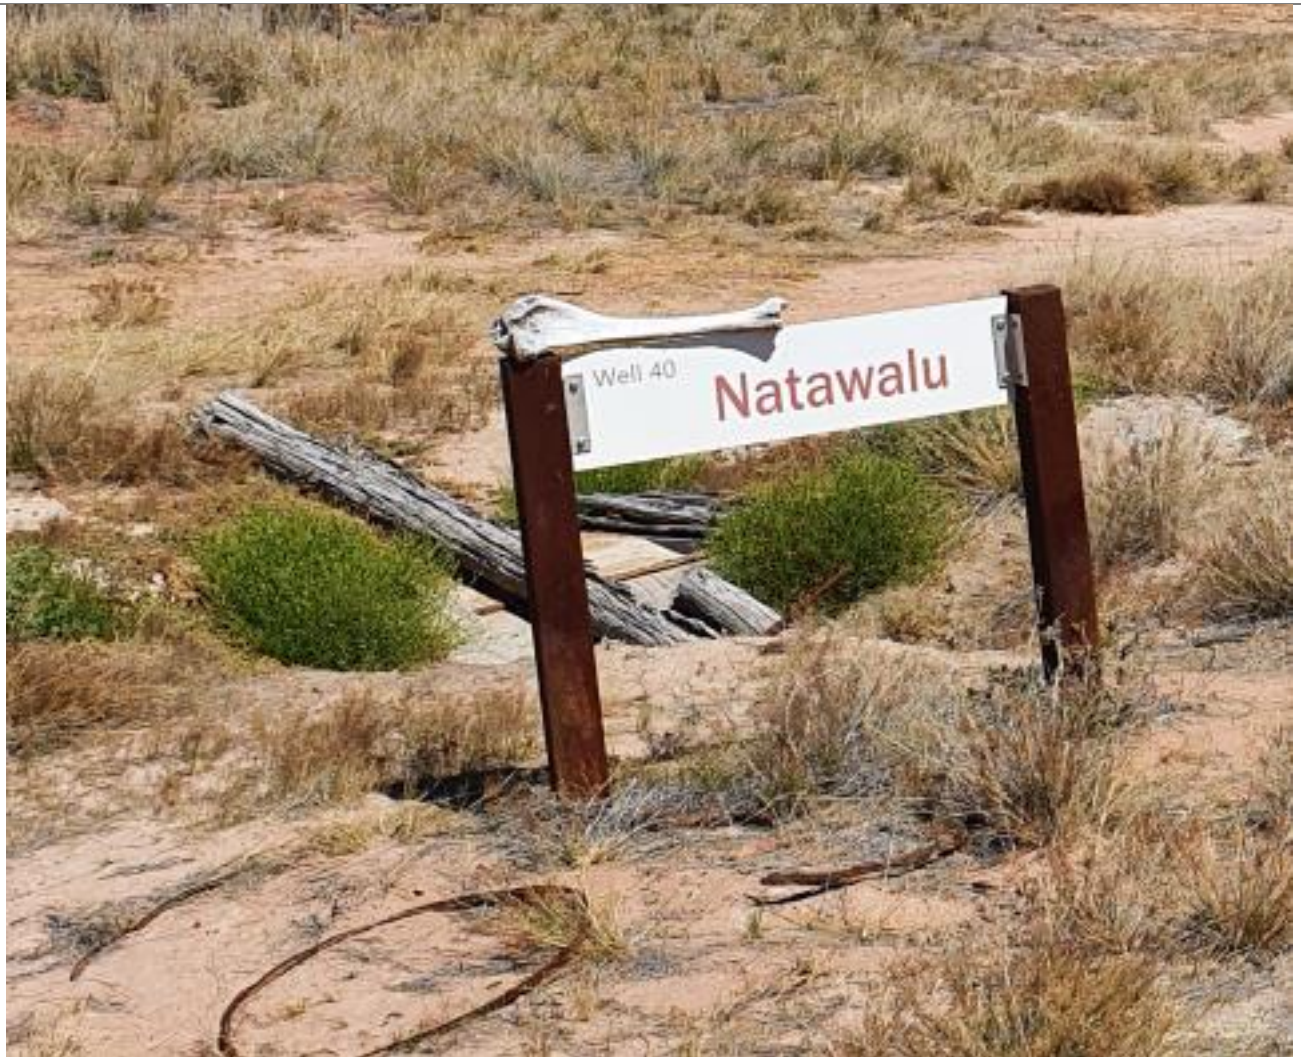
Well 40, Natawalu,

Unmaintained, dry. Well opening covered with timber/ply sheets, Signage on rusty cattle trough barely readable, very small area, low scrub. Graves of Michael Tobin & Mungkututu nearby in good condition.

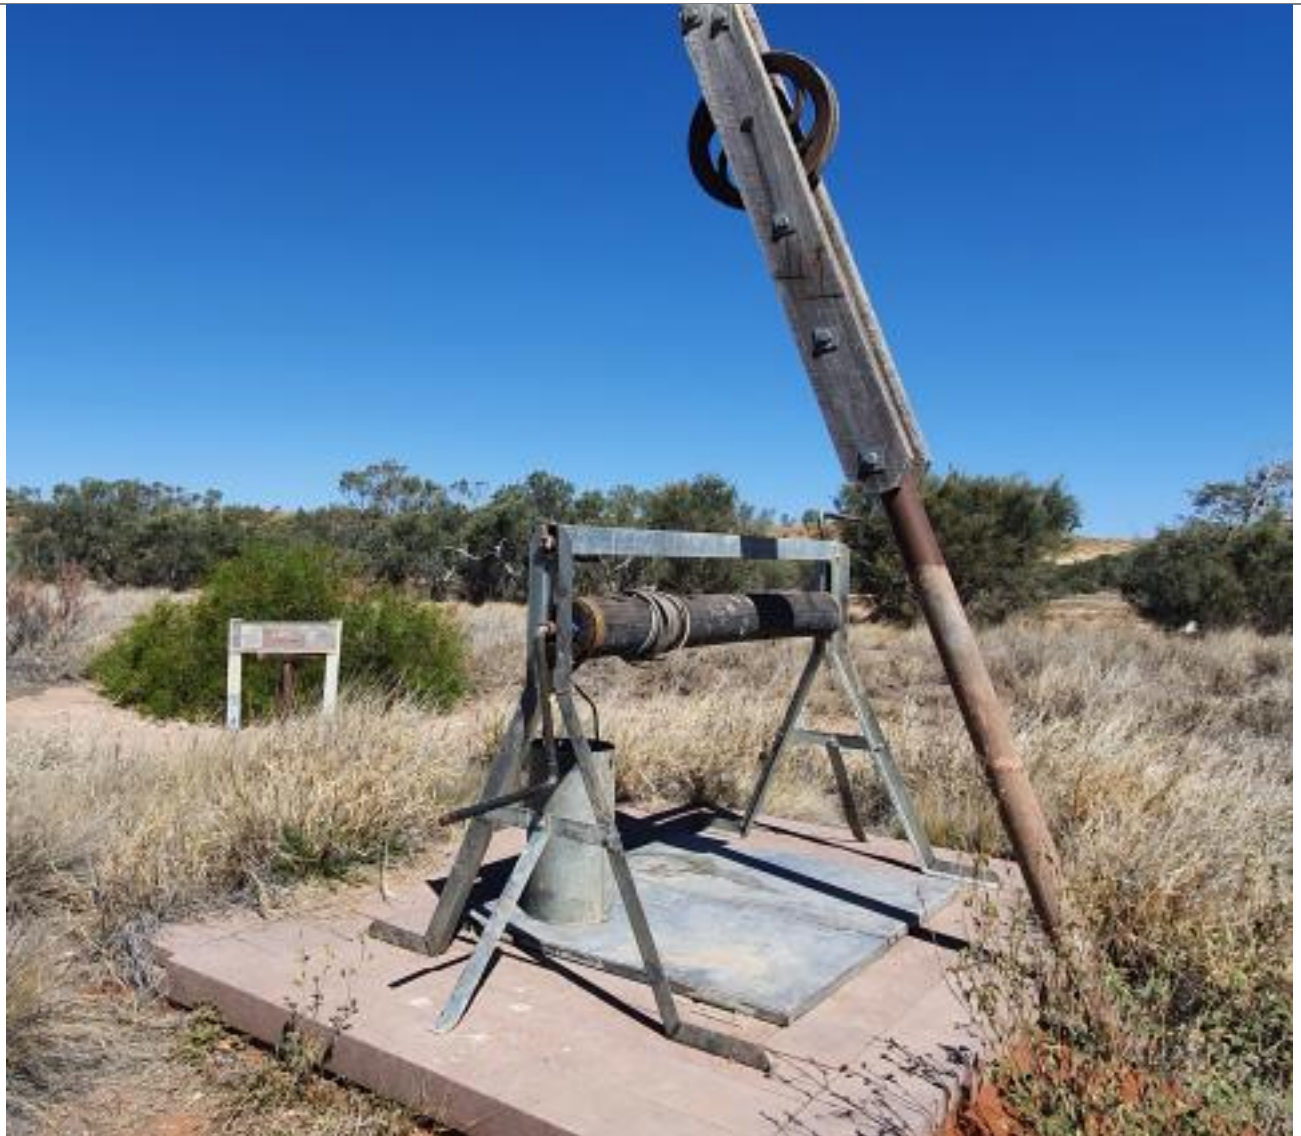
Well 41, Tiru,

Well in good repair. Toilet in good repair, toilet signs in good repair, waste dump point relocated to salt pan, new direction sign required, toilet direction sign created on steel drum, no visible solar light, toilet pathway cleared, small camp area very exposed.

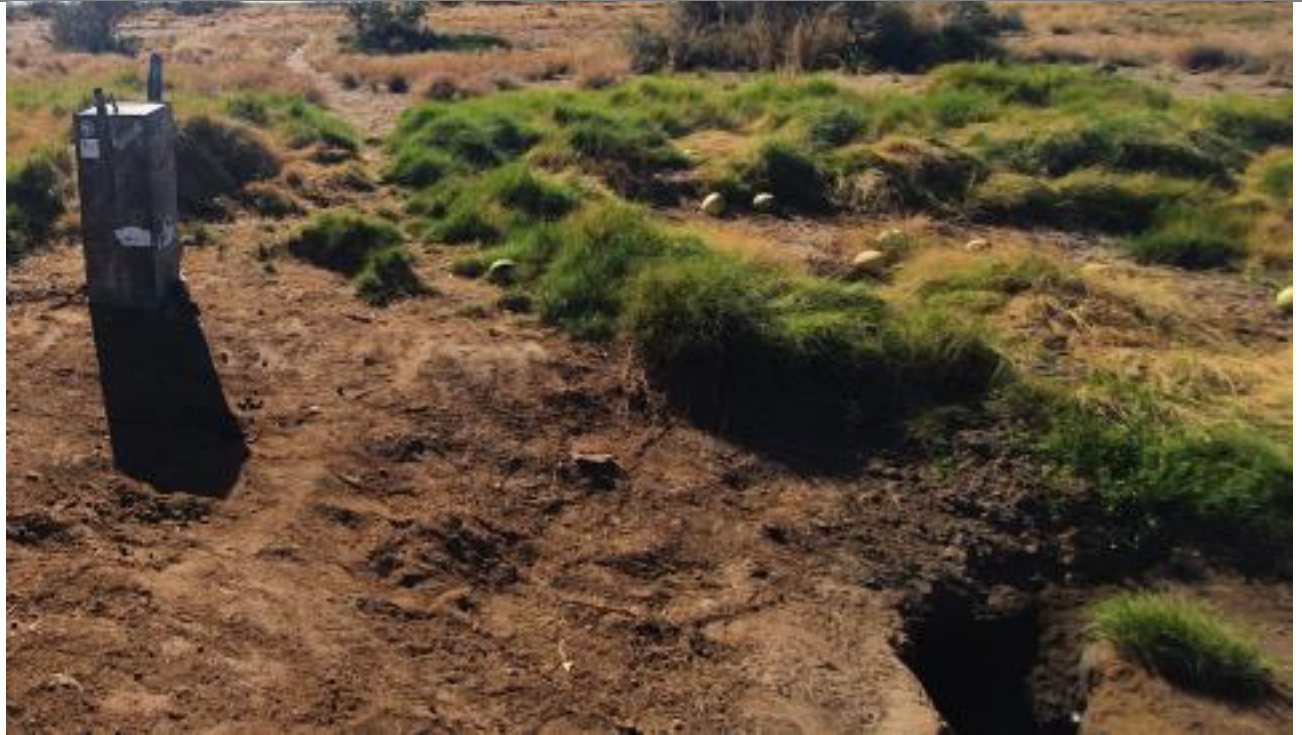
Well 42, Kulyayi**Lat. -21.315304****Long. 125.882416**

Unmaintained, water available, Signage poor (old tank written on), Very exposed med sized camp area, sand base, Buffel grass, good tasting melons!

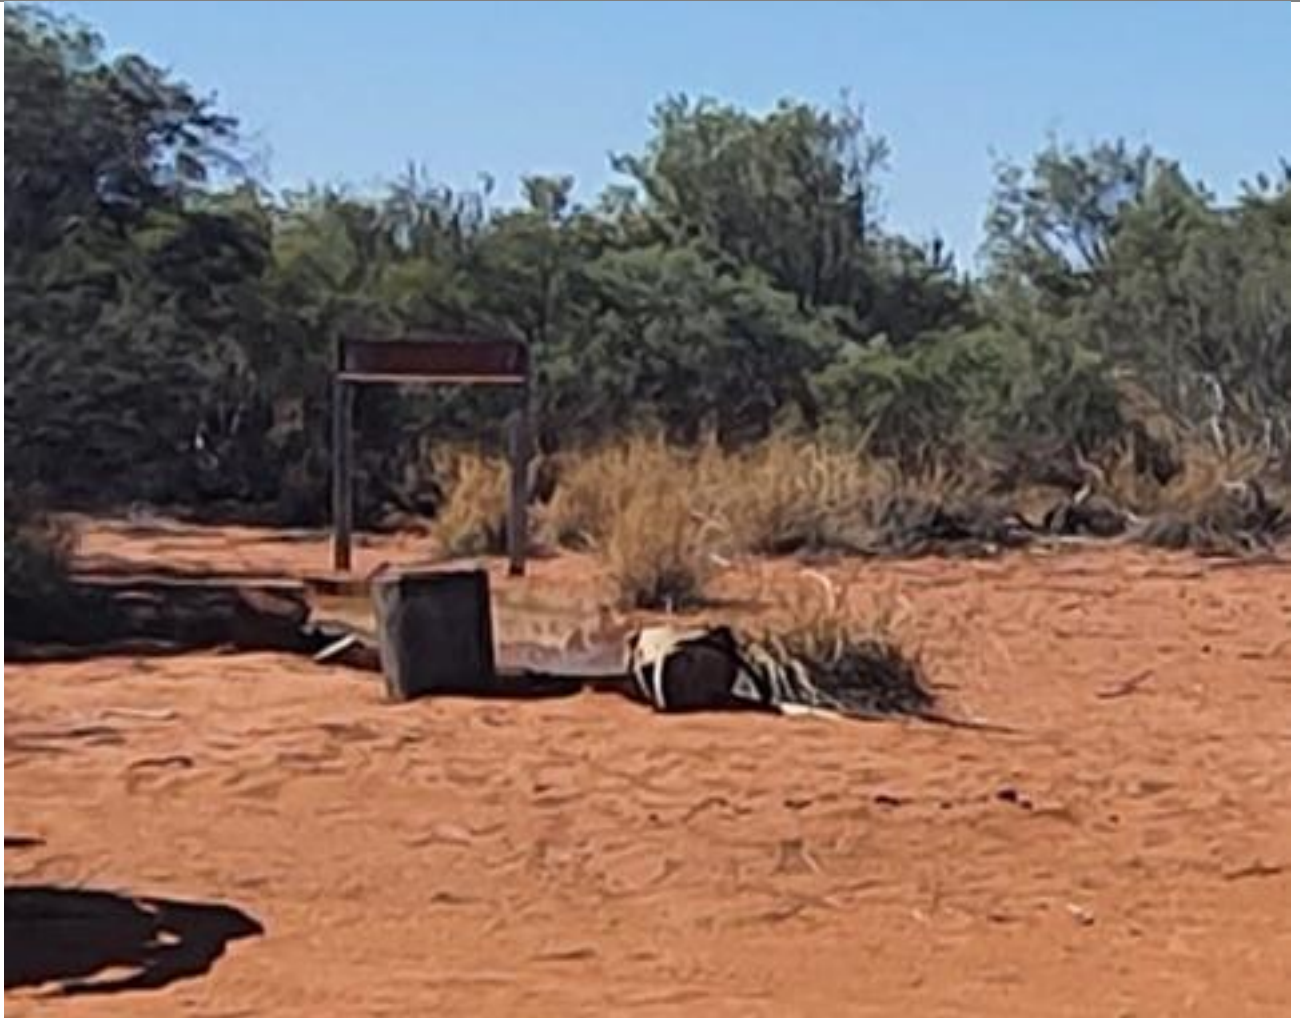
Well 43, Katajkarra**Lat. -21.212815****Long. 125.973336**

Unmaintained, filled in. Signage poor (scratched on old rusty drum), small/med size camp area, sandy, Buffel grass.

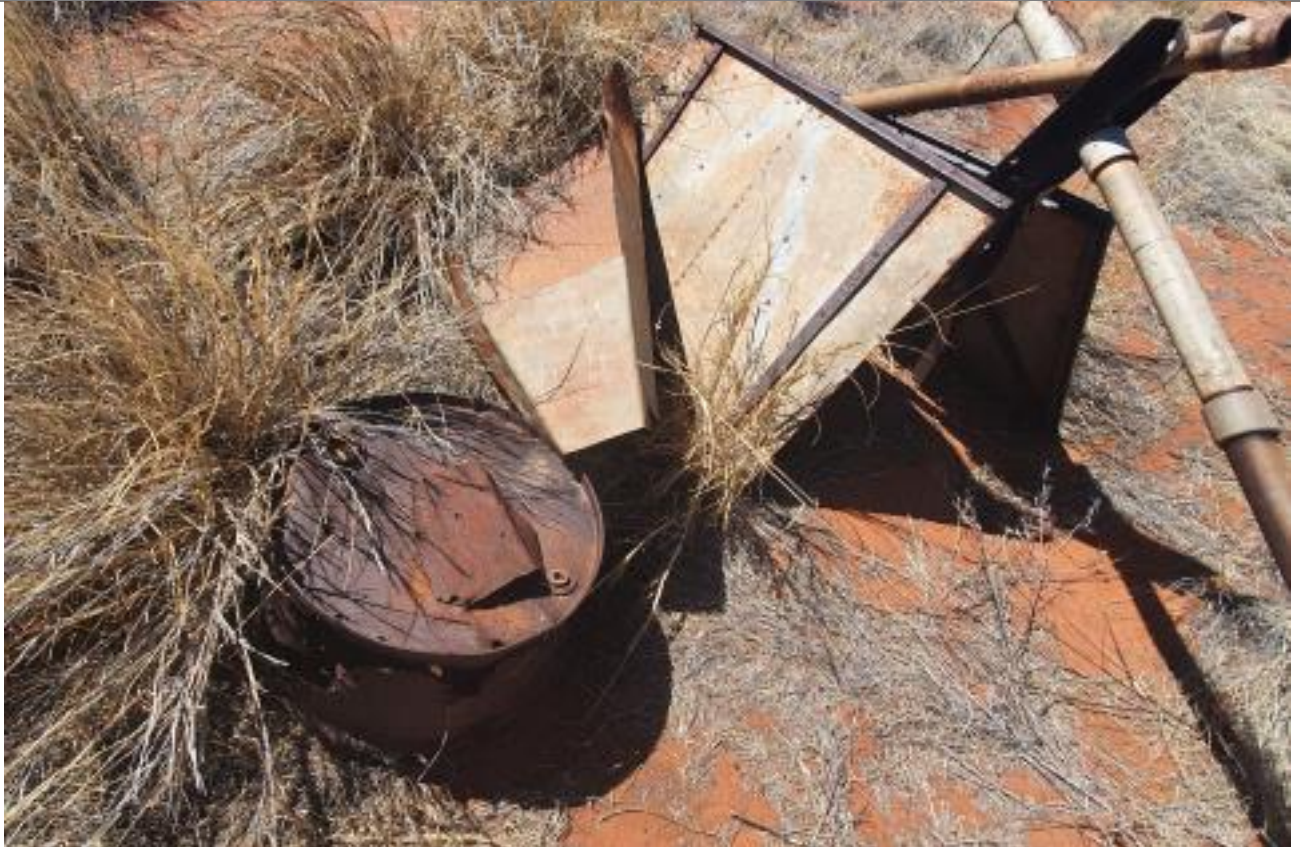
Well 44, Jimpirinykarra**Lat. -21.013631****Long. 126.150095**

Unmaintained, filled in. Signage very poor (scratched on old trough), Open & exposed area, sand base, Buffel grass.

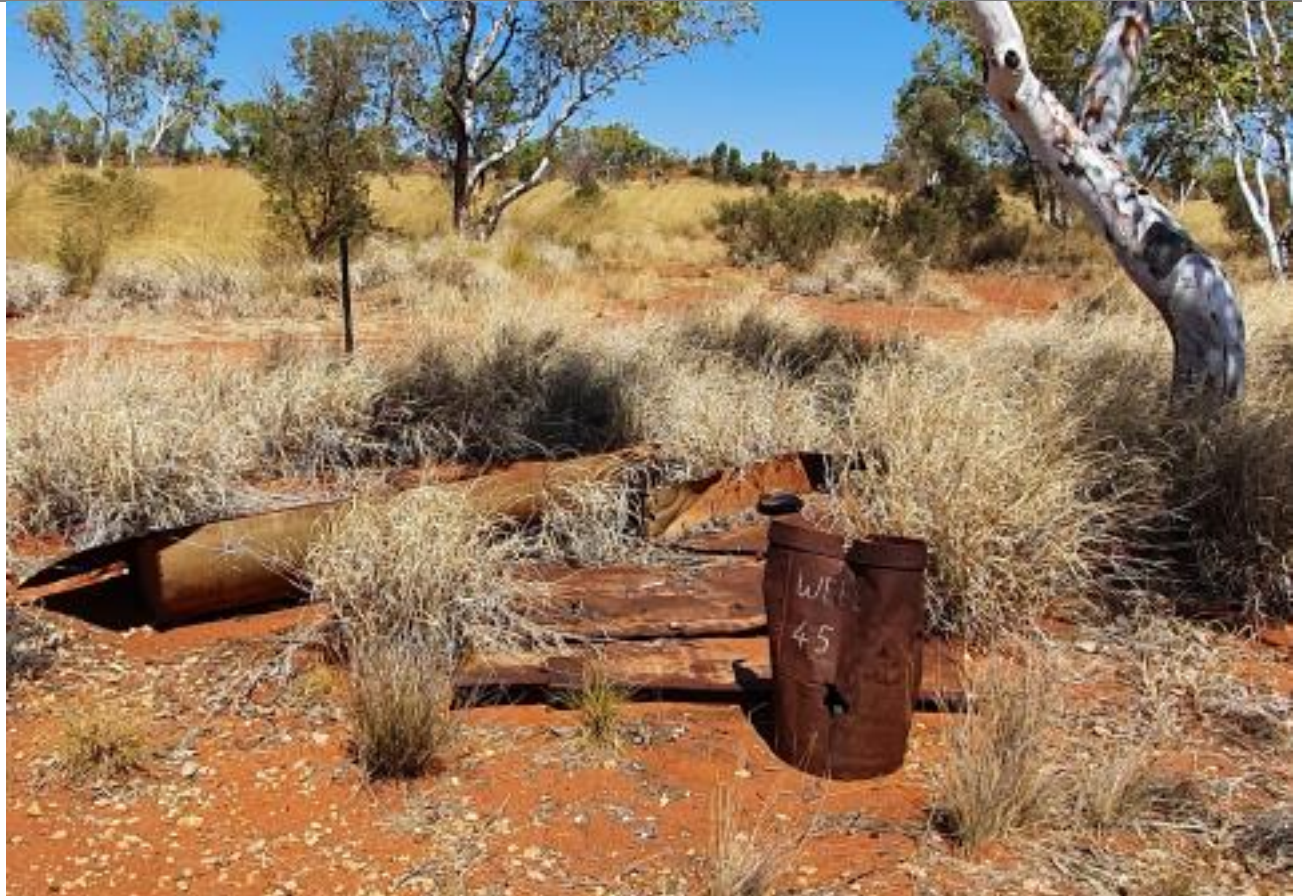
Well 45, Jintijinti

Unmaintained, filled in. Signage very poor (scratched on rusted bucket), small open area to camp, low trees, little shade, sand base, Buffel grass.
