Canning Stock Route Audit Report

Prepared for Track Care WA
Author: Rod Durston
August 2022

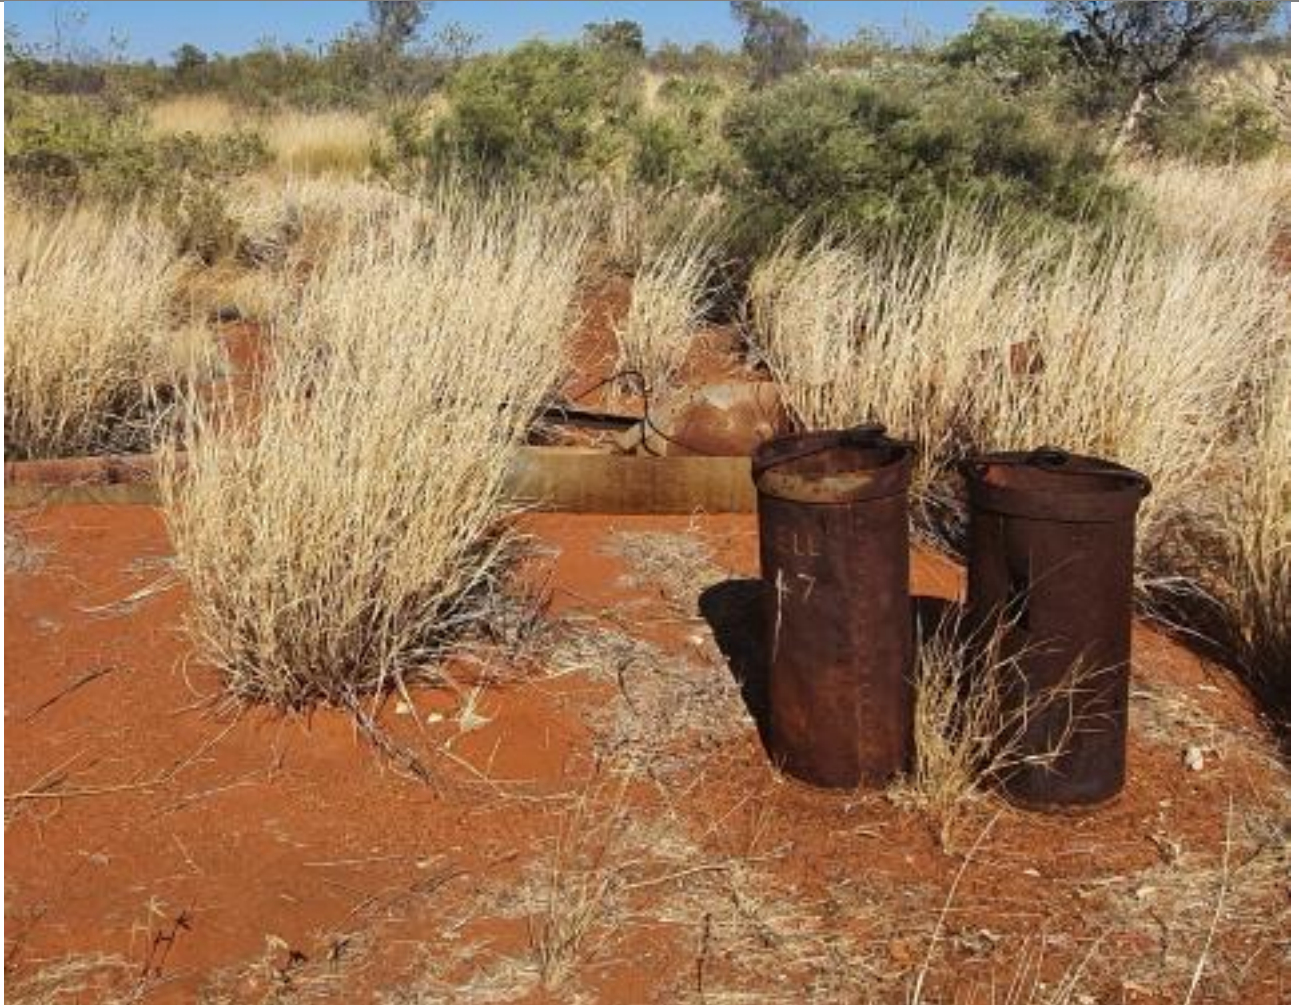
Well 47, Kartalapuru

Unmaintained, filled in. Signage poor (scratched on rusted bucket) plus small metal sign stamped 47. Very small, exposed area to camp, sand base, Buffel grass.

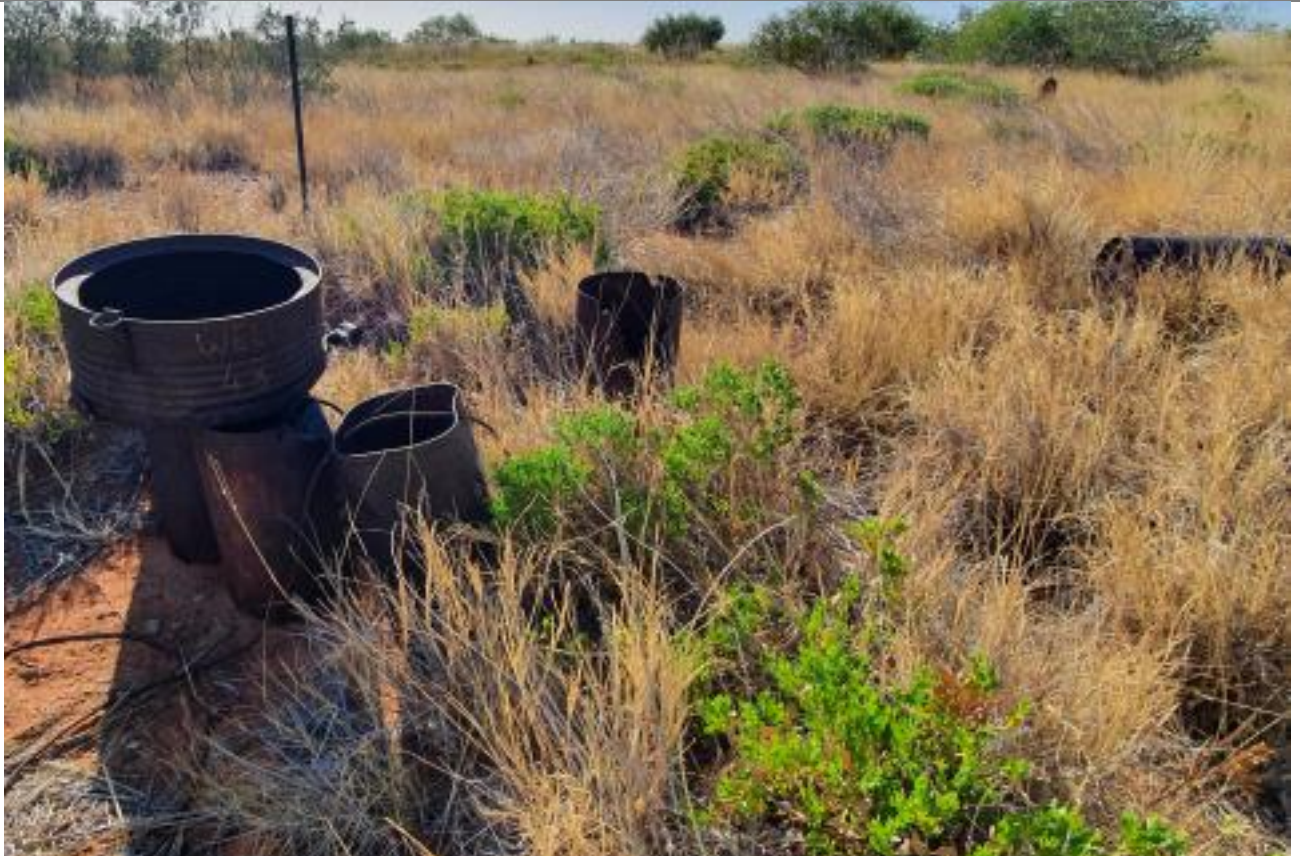
Well 48, Kaningarra**Lat. -20.248463****Long. 126.523586**

Unmaintained, Filled in. Signage v poor (faint scratched on rusty drum), Very small, exposed area, sand base, Buffel grass.

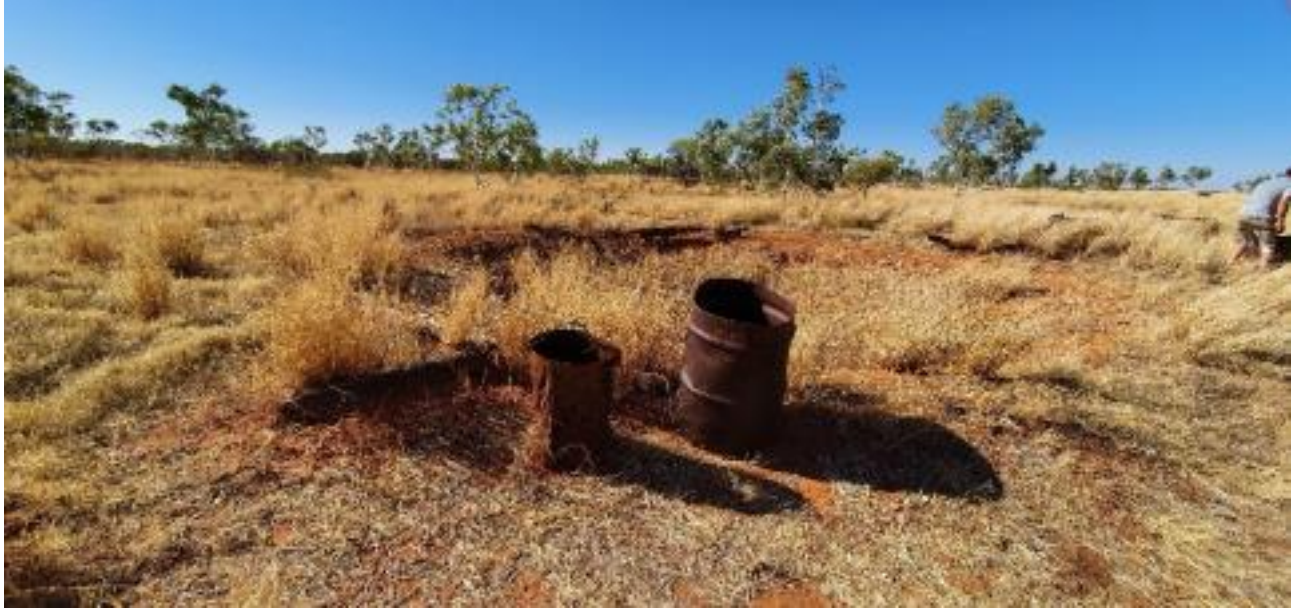
Well 51, Wirrijarra**Lat. -20.147733****Long. 127.146307**

Unmaintained, filled in and windmill severely damaged. Open & exposed.

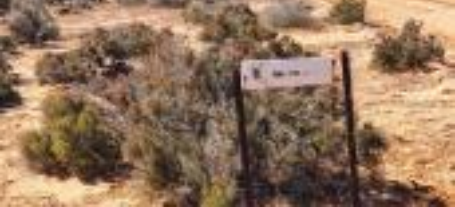
SIGN FEINT ARROW TO CSR	-25.670134	120.590543

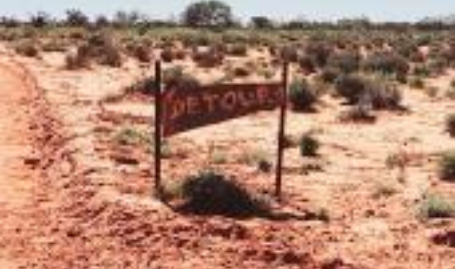
SIGN 2X CSR DETOUR	-25.665595	120.592528

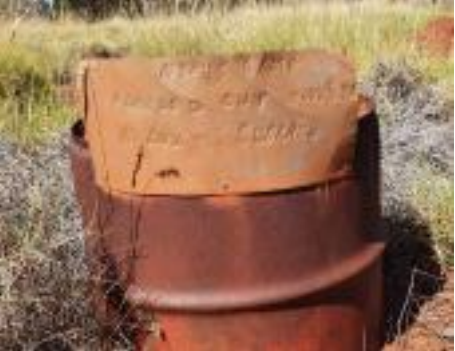
BM FX33	-24.285770	122.052657	
BM FX 32	-24.219892	122.074643	
SIGN FLOOD MESSAGE ON DRUM	-24.192270	122.094370

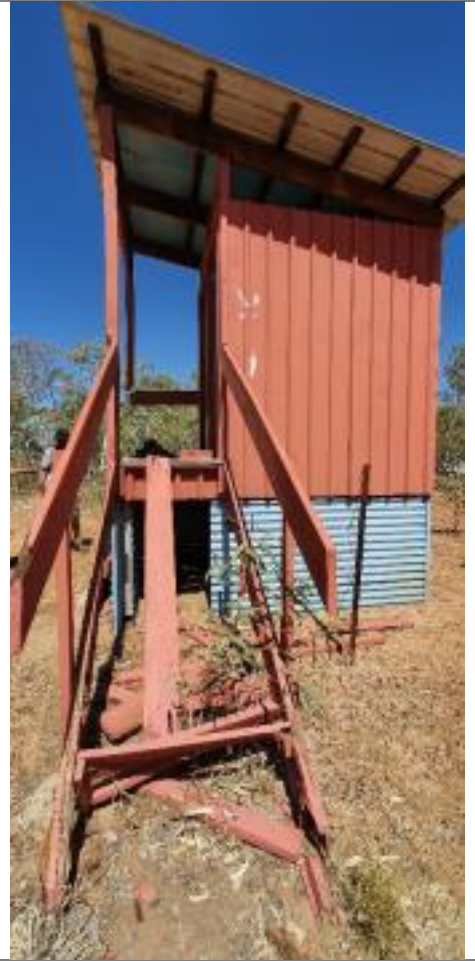
TOILET

Structure has significant termite damage and is in a dangerous condition. Composting bin and pedestals seem to be ok. Solar system present but unknown use or condition.

Some of the toilet trailer tyres at Derba Springs and Well 49 needs replacing and the toilet at Lake Stretch is in a dangerous state due to termite damage. At the time of writing it's unknown who

constructed this toilet and therefore who should repair it. It will be a major project to complete as it requires a complete rebuild. Apart from some minor repairs undertaken, in general the toilets are in good condition there does not seem a need for extra toilets along the CSR.
